Blueprint Building Inspections  
60 Symons Street  
Toronto, ON M8V 1T9

# Inspection Report

1041 Woodbine Ave  
Toronto, ON M4C 4C1

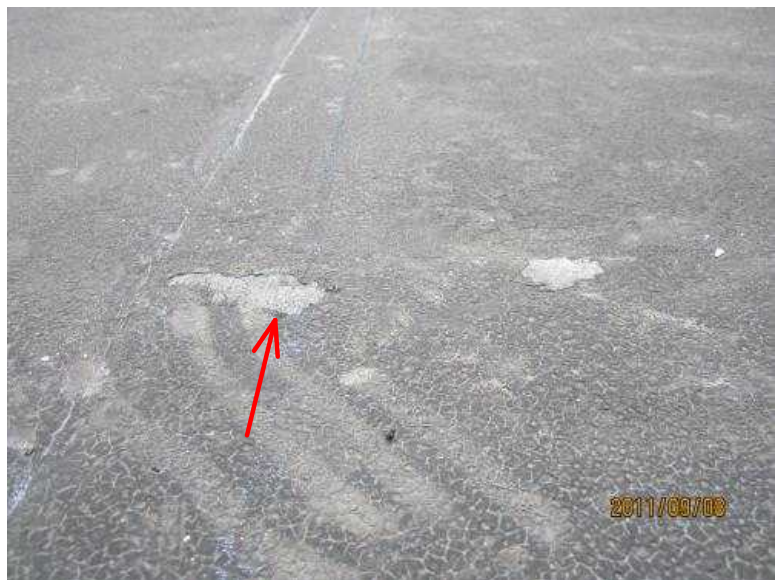
5. Method of Inspection: On roof
6. Acceptable Material: Rolled roof material (EPDM): There is some alligator cracking developing in the EPDM membrane, and this shows a drying out of the surface. Consider a specifically designed aluminum coloured paint to reflect the UV rays of the sun. Add some tar at the 2-3 spots where the top surface shows some peeling.

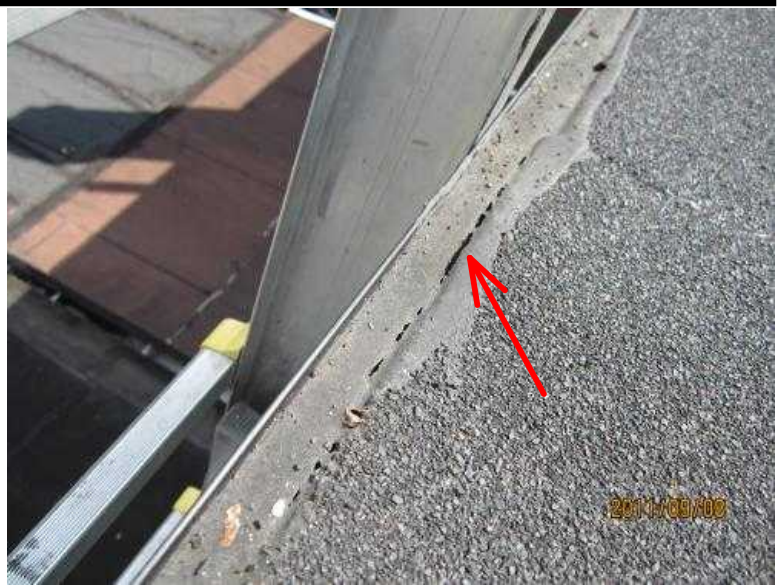
12. Marginal Wall/Edge Flashing: Metal:  
Tar/caulk needs regular monitoring to ensure its water integrity. Minor separation now makes the rear edge prone to possible leaks. Add tar in the short term

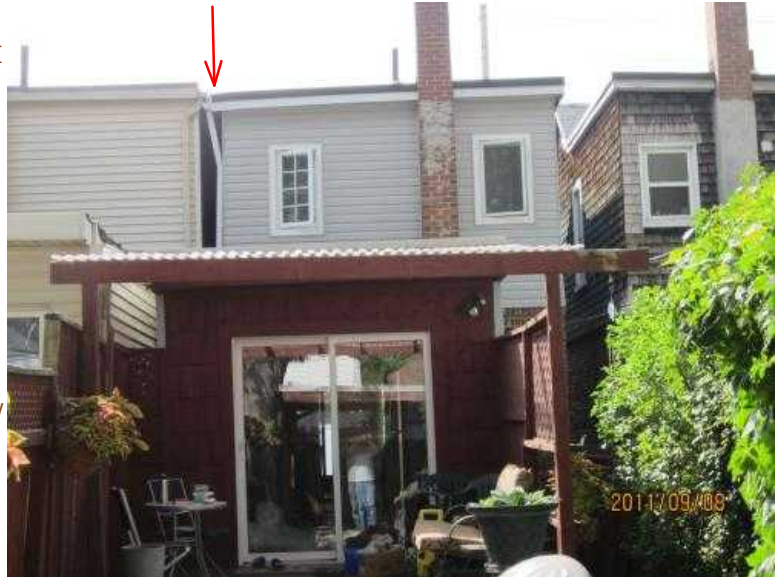
20. Investigate Leader/Extension:  
Indeterminable: Restricted at SE corner - not visible. Confirm downspouts are taking water well away from the foundation. When roof water runs into underground pipes, the possibility exists for water to spill through any openings into surrounding soil. This water puts hydrostatic pressure on the foundation and can enter the basement. If the downspout drainage appears to be running into the soil, then they should be disconnected from the underground pipes and directed 3-6 feet away from the foundation.

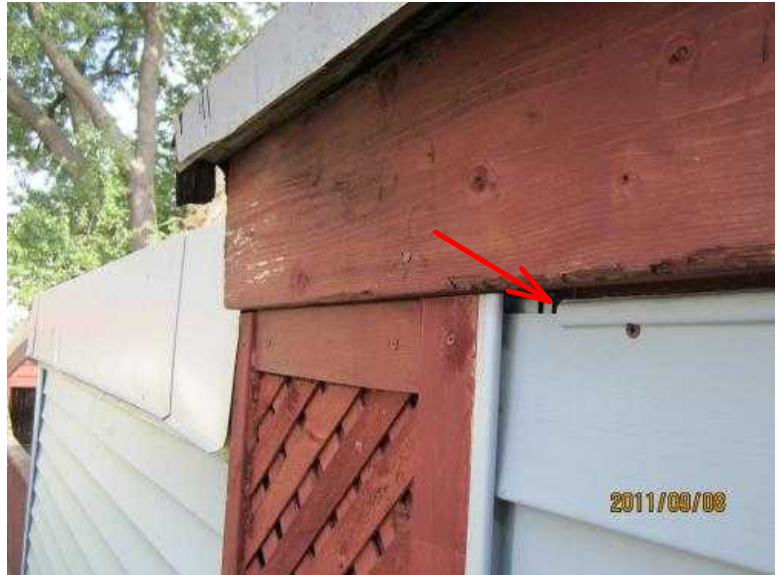
2. Acceptable Type: Vinyl siding: Improve top flashing of siding at rear addition to ensure water does not run down behind the siding

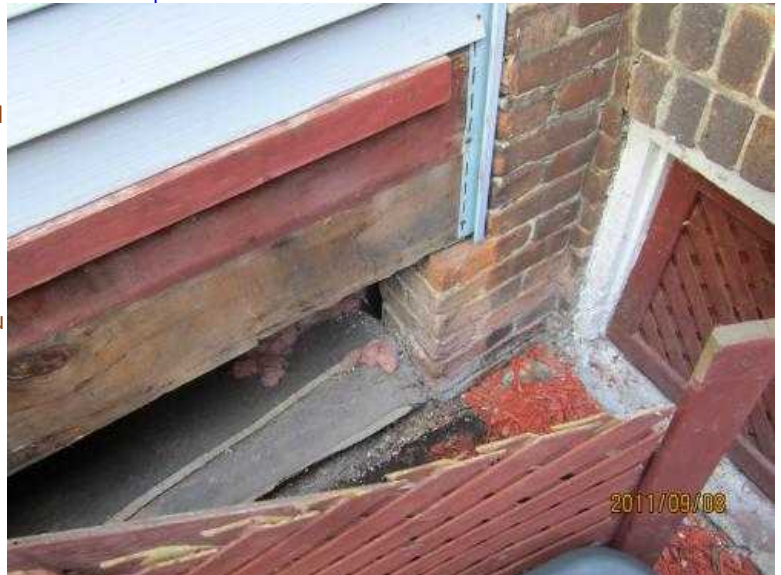
4. Investigate Access: Partially blocked:  
Crawlspace access is restricted. Inspectors prefer to have full access in order to provide full and complete information. In cases such as this, a few suggestions have been made in this section, indicating what to look for when evaluating further. These do not necessarily mean there are problems, but we try to guide you in the correct direction with respect to further evaluation.

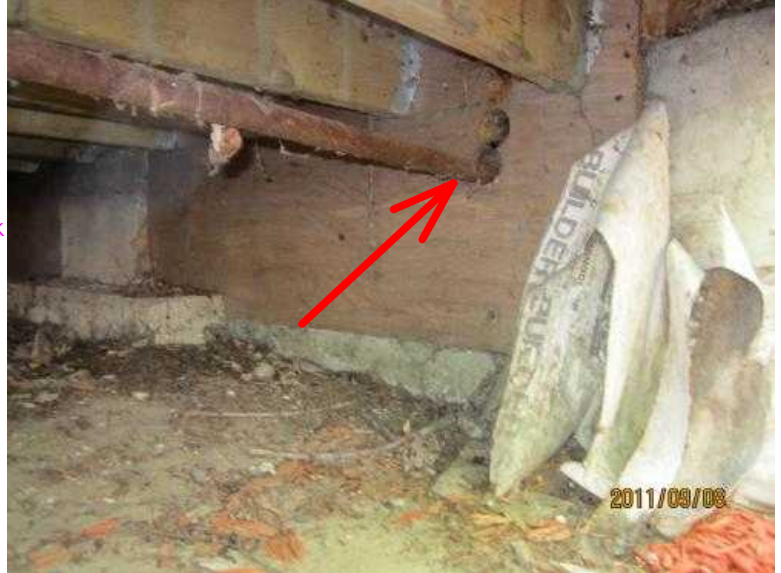
Insulation: Fiberglass:

Insulation exists, but some is falling. There is a freeze risk for the plumbing in the kitchen, so we suggest that the plumbing pipes be insulated or heated. To minimize the potential for drafts in the room above, stapling Tyvek house wrap to the bottom of the joists will restrict air flow and drafts into the floor structure and keep the insulation in place.

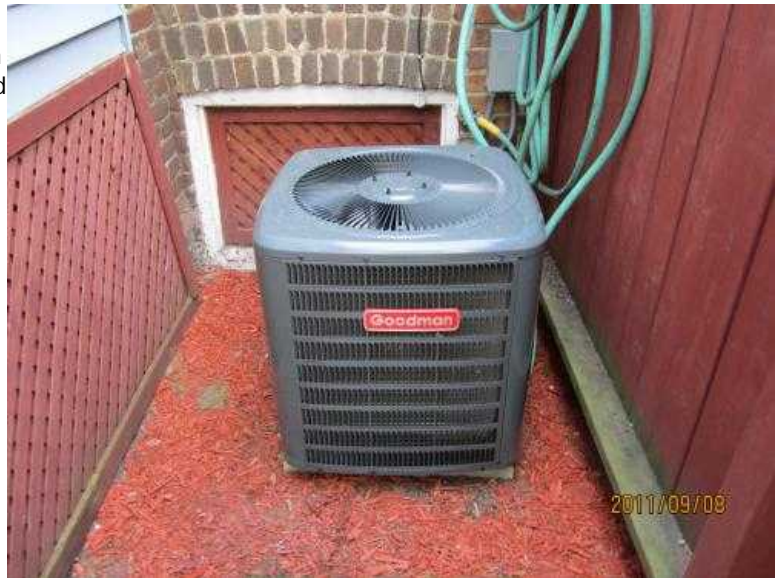
2. Acceptable A/C System Operation:  
Functional: Expected life span in our area is +-15 years. A qualified air conditioning contractor is recommended to evaluate and do annual maintenance on system, which can provide more information on its condition and performance.

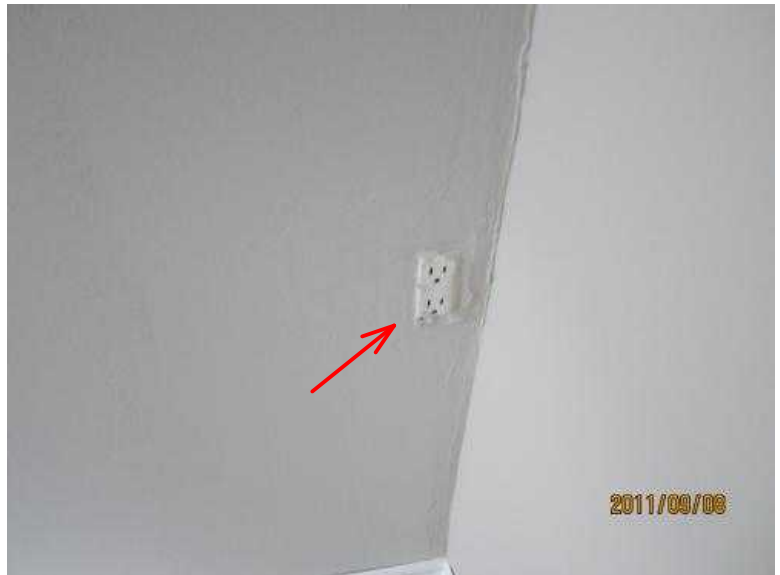
8. Marginal Electrical: 15 amp 3 prong (110 volt) receptacles, 110 volt lighting circuits: **Drywall filled in around one 2nd floor receptacle - should be reconfigured to allow for installation of a protective switch plate - minor issue.**
