# Inspection Report

15 Canterbury Crescent Etobicoke, ON

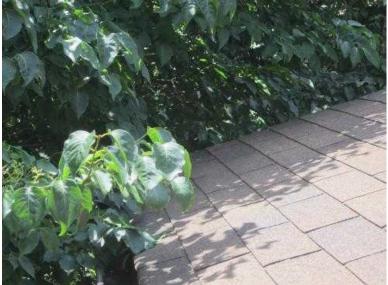
Material: Asphalt shingle: Most roofs are designed to last 15 years and become unreliable as that age approaches, Typical wear and tear - expanded seams, edges wearing, minor edge curl, previous repair evidence, commencement of brittleness. Expect replacement in next 4-5 years approximately, Estimated age is based on wear patterns - roof may be older or younger than estimated.

Keep trees trimmed away from roof, otherwise roof longevity may be shortened

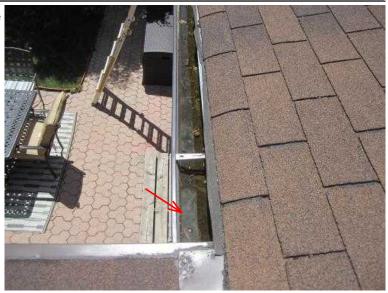
10. Acceptable, Improve Gutters: Aluminum: One low spot holding water at back patio - minor repar

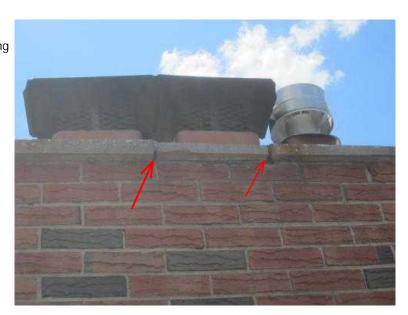
14. Acceptable, Improve Flue/Flue Cap: Clay,
Metal liner: Suggest filling
the joints in the concrete
cap with mortar, or there
will eventually be some

brick damage.

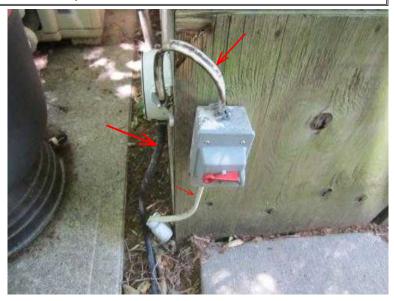
15. Marginal

Exterior Wiring: 110 VAC: Exterior wire should be protected by being routed through conduit. Suggest improvement at the pool pump.

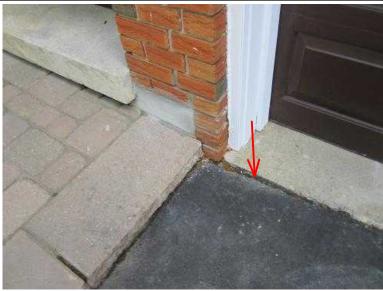
2. Acceptable

Driveway: Asphalt: Caulk the joint between the driveway and the garage to keep water from entering

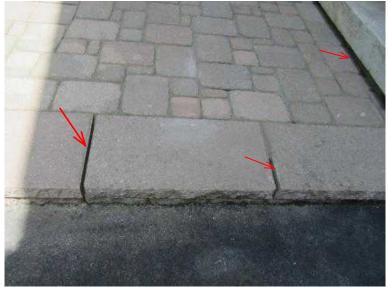
3. Acceptable

Steps: Paving stone, Precast concrete: Joints of the paving stones should be "sanded" annually (consider a plasticized sand so it does not run away)

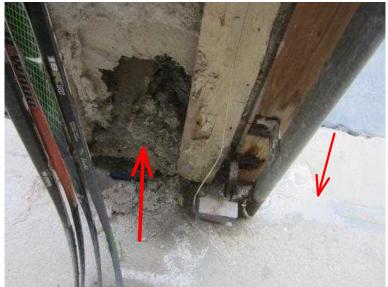
7. Marginal

Walls: Drywall: Drywall has absorbed moisture and should be repaired at bottom between garage doors. Minor puddling on floor at this location (see arrow in photo) but unknown source of moisture (condensation form car exhaust? hose may have been previously on?).

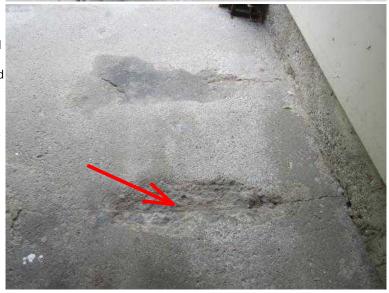
8. Acceptable, Improve Floor/Foundation:

Concrete: Concrete shrinkage cracks are typical and non-structural. Crack where moisture has entered has caused corrosion in the underlying metal and popped up the concrete - minor repair to prevent this from worsening

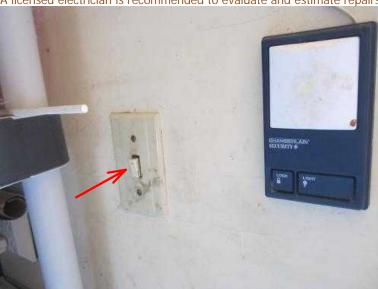
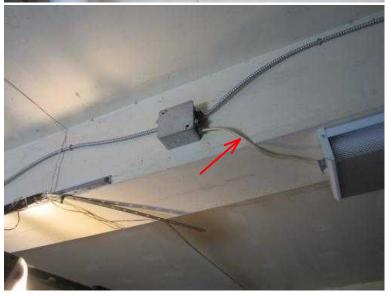
It is preferable to use armoured cable where mounted on the drywall surface, as opposed to regular cable (minor and common note).

A licensed electrician is recommended to evaluate and estimate repairs

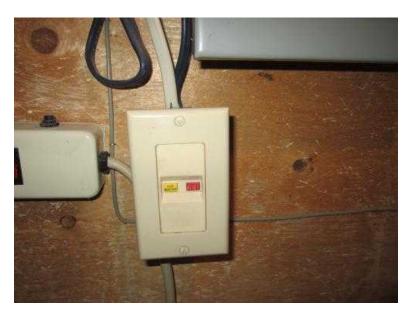
16. Acceptable GFCI: At panel: Not certain what this GFCI controls - likely

the pool pump

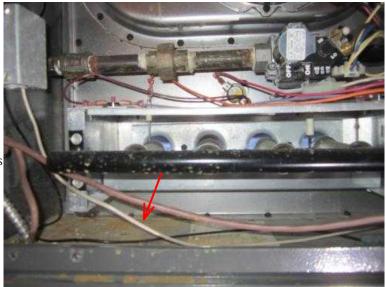
7. Acceptable, Investigate Heat Exchanger: 4

Burner: Minor water staining in furnace. Water may have run down from the floor above as there is no obvious source. Stains should be cleaned and monitor for new signs of staining. No negative effects in evidence at this time. Consult your heating technician about this during annual maintenance.

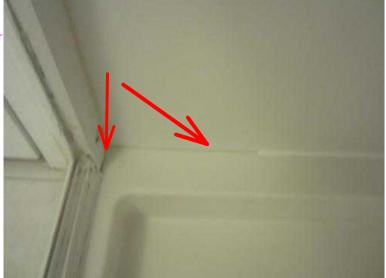
Replace old caulking at the shower

pan
