Blueprint Building Inspections
60 Symons Street
Toronto, ON M8V 1T9

Inspection Report

280 Kenilworth Avenue
Toronto, ON

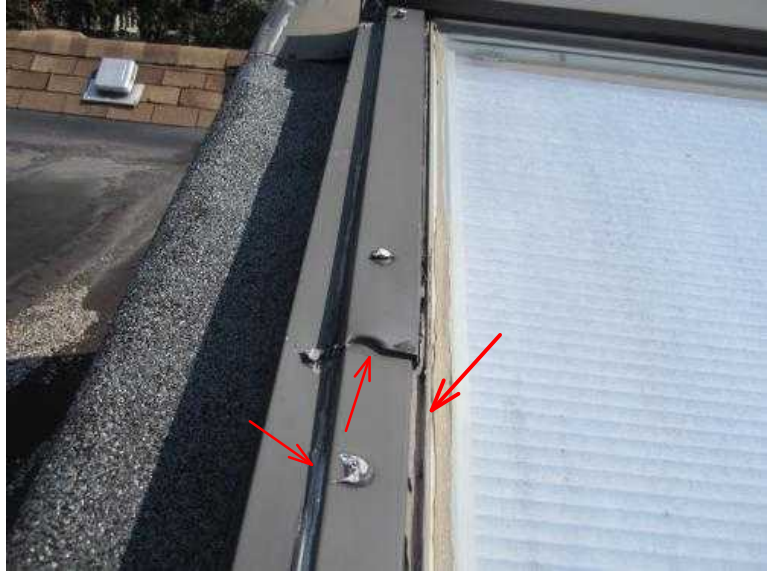
12. Acceptable, Investigate Skylights: Glass, Curbs: Older skylight has had enough wear and tear over the years that the flashing and caulking should be attended to. Have a skylight professional evaluate the skylight, and consider that replacement when re-roofing might be a good option.

13. Marginal Skylight Flashing: Metal: Prone to possible leaks where caulk is peeling - professional attention required

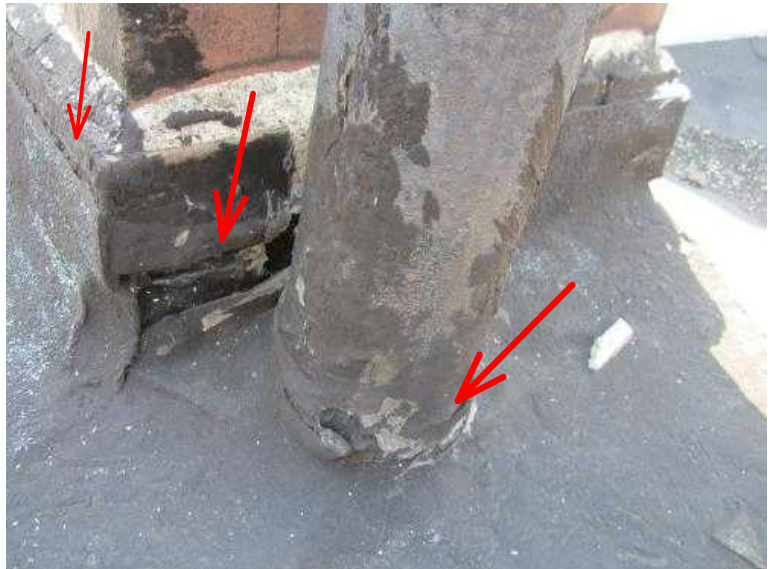
14. Acceptable Plumbing Stacks: Cast Iron
15. Defective Stack Flashing: Rolled roof material, Tar: Prone to possible leaks - immediate attention required

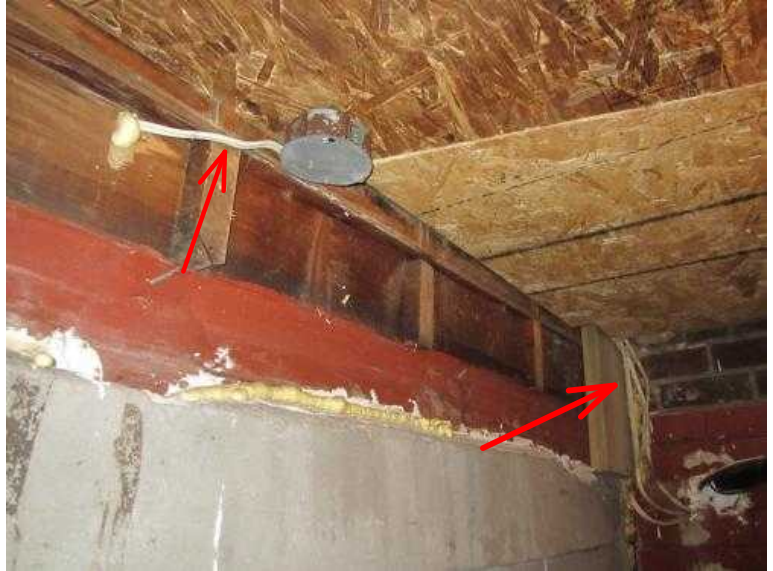
22. Acceptable Exterior Wiring: In conduit, Surface mounted wire: Suggest adding physical protection to the exposed wiring in the rear.

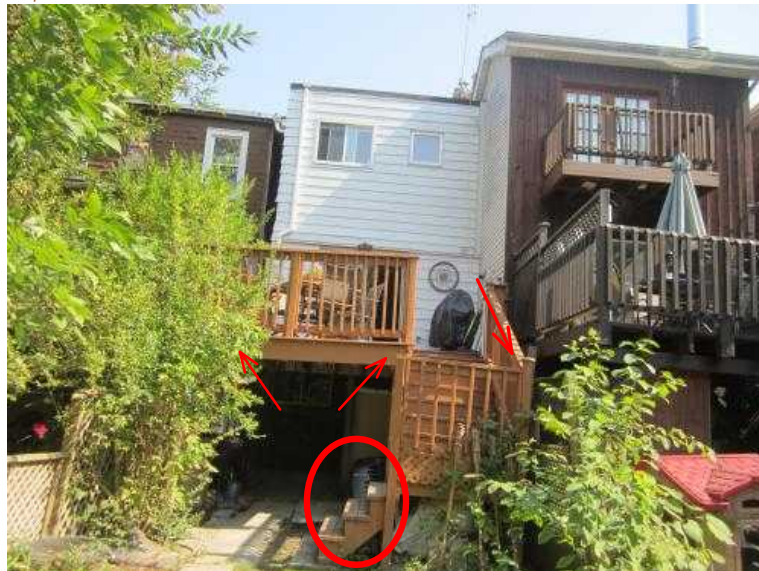
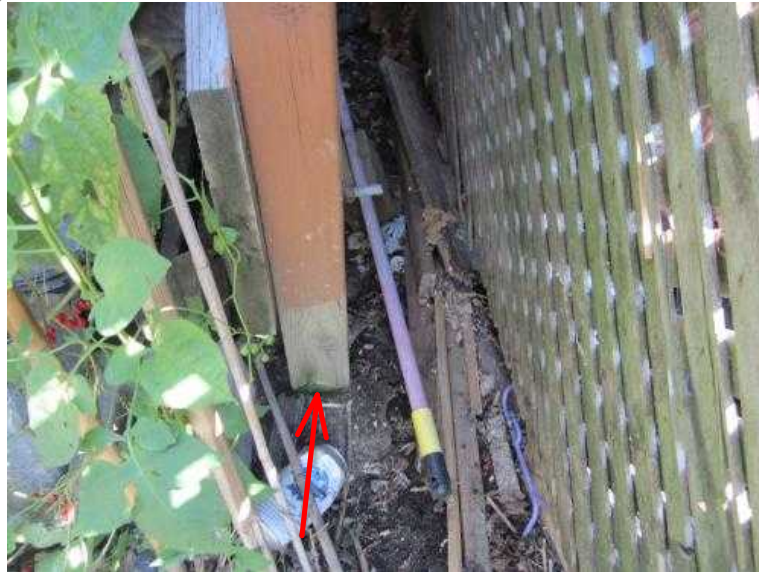
5. Investigate, Improve **Deck: Wood:** Close wood-soil contact in known termite area, but no visible termite evidence. Minimize wood to earth close contact in known termite area. Unable to confirm there are or are not termites on the property due to the fact that this is a visual inspection. However, no termite evidence was detected today anywhere on the property. Suggest an approach to lower risk by minimizing and removing wood-earth contact as repairs are made.
Front deck: stairs need railing.
Back deck: Railings need improvement also, and note that some portions of the deck have settled (see arrows). Since it is a raised deck, this repair should be made a higher priority. While doing so, minimize wood-earth contact.

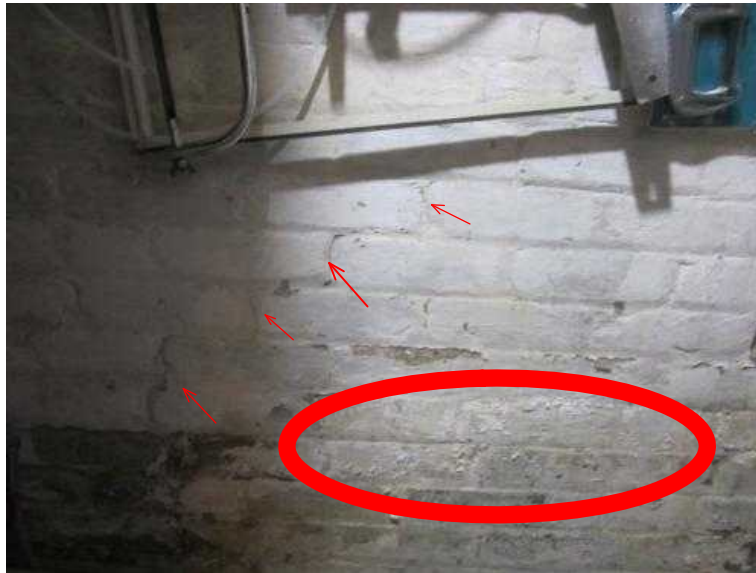
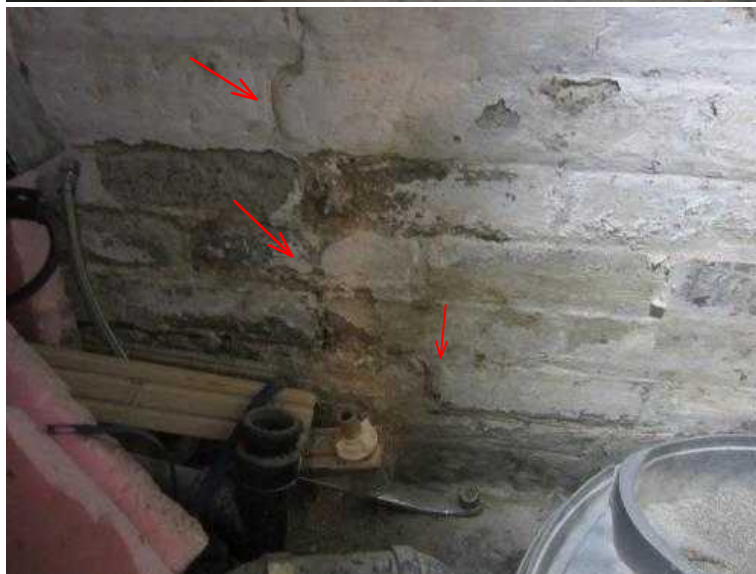
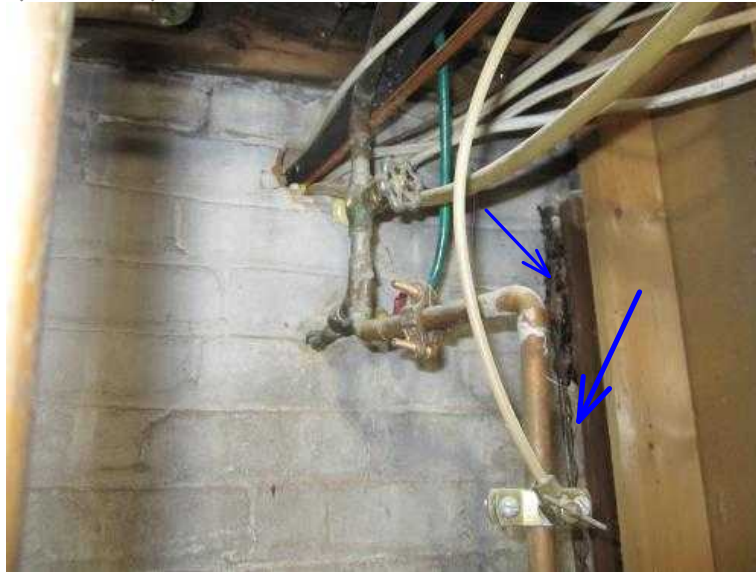
3. Marginal

Foundation: Brick: Today's inspection is a one day snapshot - monitor movement, cracks and dampness over time, Brick foundations are more prone to moisture penetration. Some step cracks visible in furnace area - monitor for future movement. Some peeling paint and chalky deposits (indicative of previous moisture) which are typical in brick foundations, almost expected in older homes. Suggest adding caulking at wood frame wall (see blue arrows in photos) where it was previously installed to monitor for future movement.

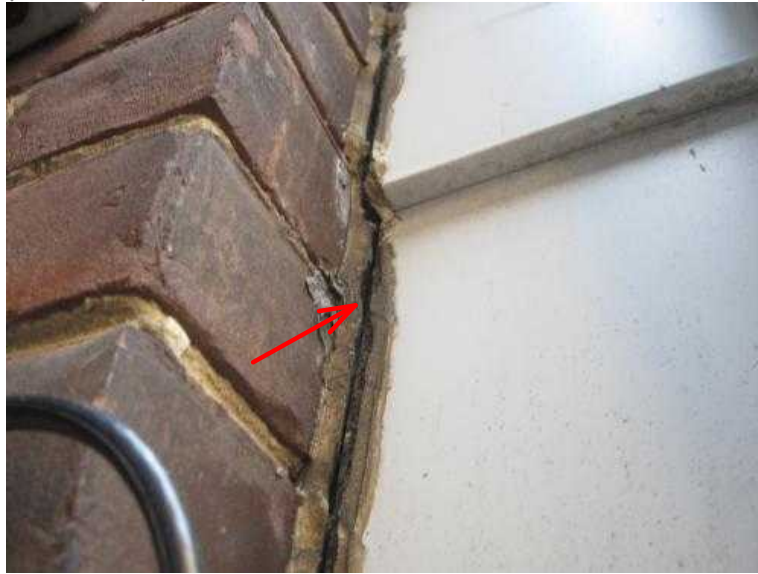
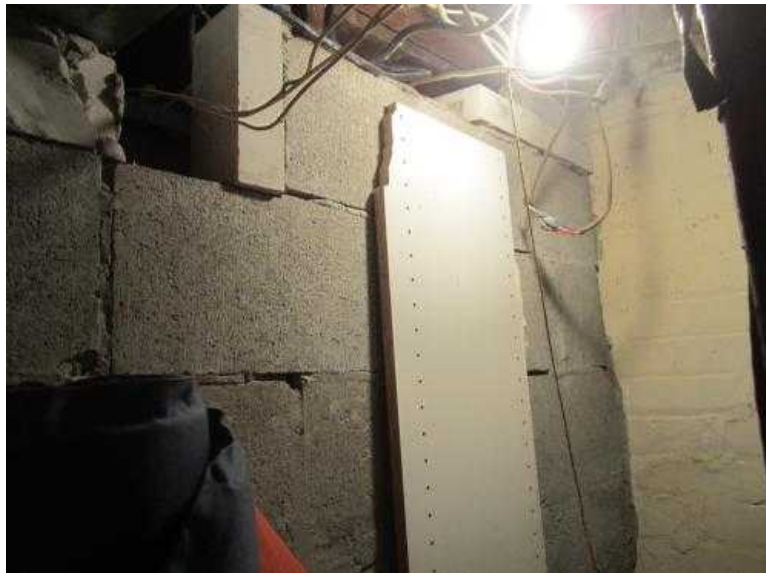
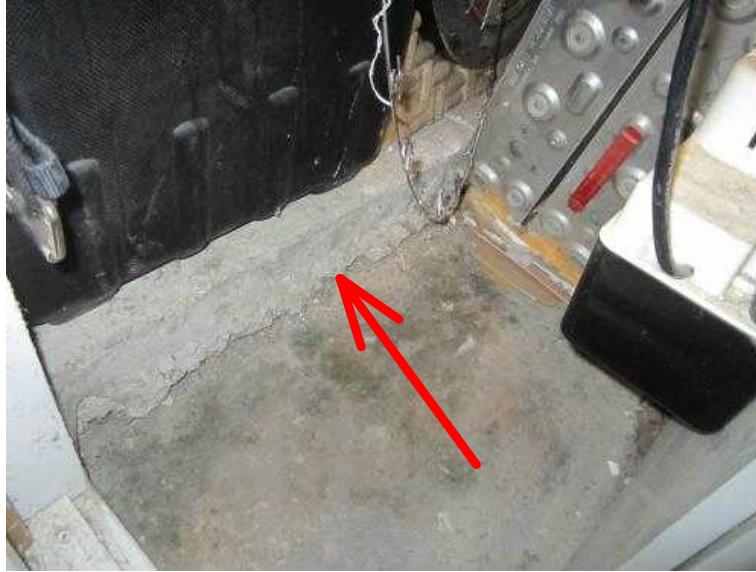
4. Investigate

Movement: Leaning structure: This building is leaning to the north. This is usually caused by soil issues or inadequate footings. In this area of the city, there are several streets with houses that lean and conventional wisdom is that underground streams are the cause. The basement has been partially underpinned and a newer block wall has been installed, which may have been part of a stabilization repair performed years ago. These situations can be stabilized to prevent further movement, and monitored by applying caulking at joints (for example, where the siding touches the brick at the back of the house and in the basement furnace room behind the water heater where caulk was previously applied). Suspect that over the last 10-15 years there has been some ongoing settlement. The prudent course of action would be to investigate in the short term in order to determine what course of action to take and when. Partial repairs appear to have already been done to some extent (you could check with the city for previous building permits) and further repairs may be unnecessary for years, but only soil testing and structural investigation beyond the scope of this visual inspection can give you the information. A structural engineer is recommended to evaluate and estimate if repairs are needed and to determine timelines.

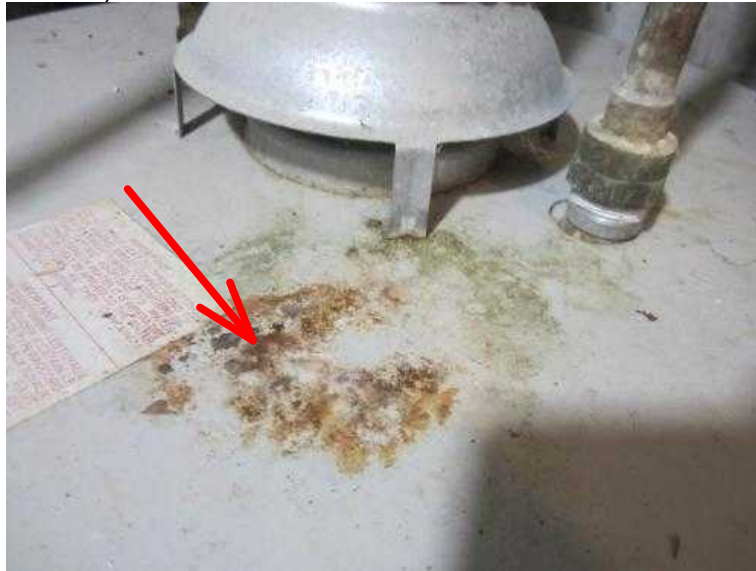
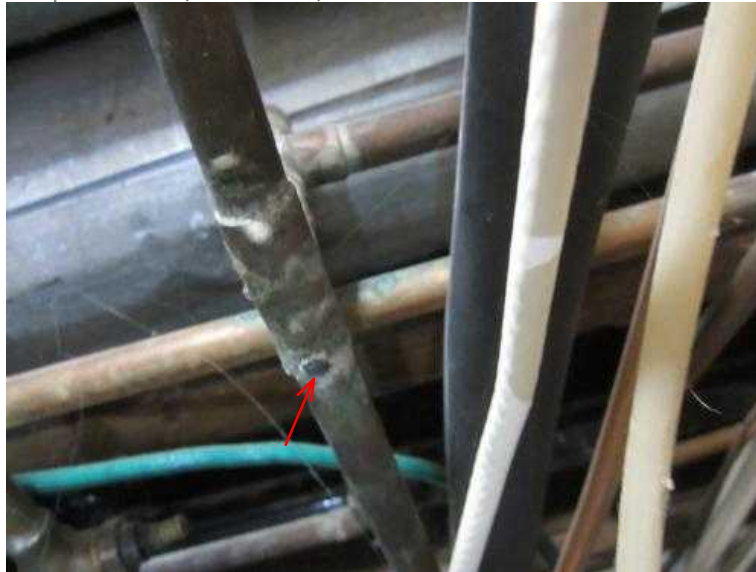
9. Acceptable Water Heater Operation: Functional at time of inspection: Minor drip marks on top of water heater - possibly a slow leak from a fitting in a copper water supply line directly above it - monitor and repair if it continues.

We suggest that you drain out a bucket of water from the drain valve on the water heater whenever you change your furnace filter. This will help cut down on sediment which will help maintain the unit's efficiency and lifespan. You will also notice any changed in water quality that would signal a need for service by a certified technician.

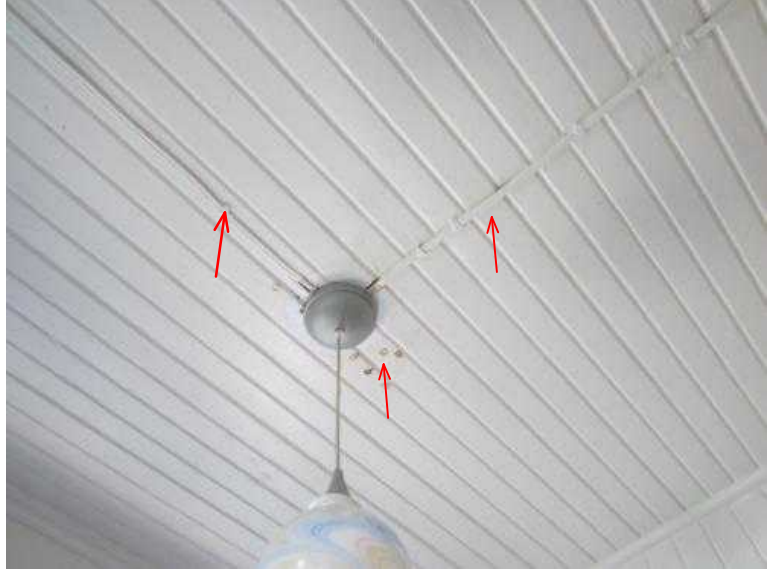
5. Acceptable Ceiling: Front Porch: Wood:
Monitor moisture stains on ceiling.
Tested dry today with moisture
meter so may not be ongoing.
Surface mounted wire should
ideally be mounted inside the
ceiling or wall or in protective
conduit.
