Blueprint Building Inspections
60 Symons Street
Toronto, ON M8V 1T9

Inspection Report

114 Beresford Avenue
Toronto, ON

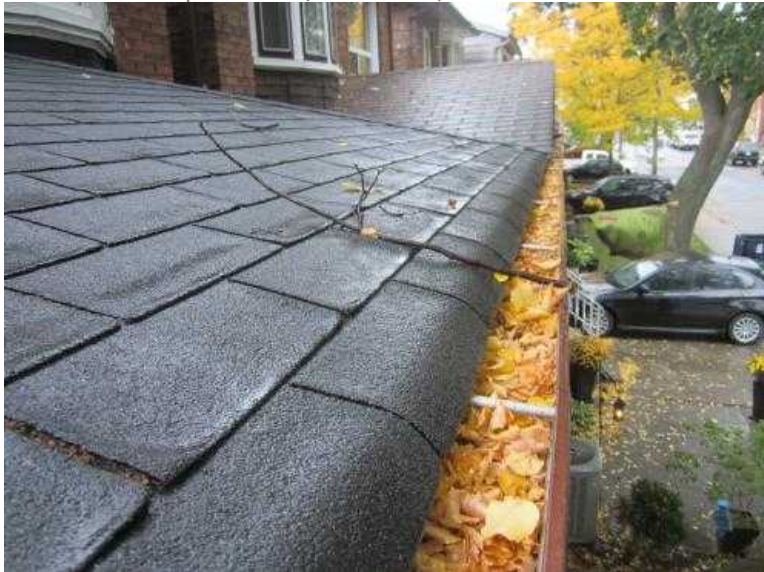
3. Acceptable **Material:** Asphalt shingle: Typical wear and tear - expanded seams, edges wearing , minor edge curl, commencement of brittleness. Expect replacement within next 5 years approximately.
Keep trees trimmed back from roof.
4. Type: Hip
5. **Approximate Age:** 10-11 years, (entering last third of life cycle): Most roofs are designed to last 15 years., Note that the age estimate is based upon the appearance of the shingles. They may be older or younger, but the wear patterns indicate the age that was recorded by the inspector, Expect replacement in next 4-5 years, as leaks probability increases

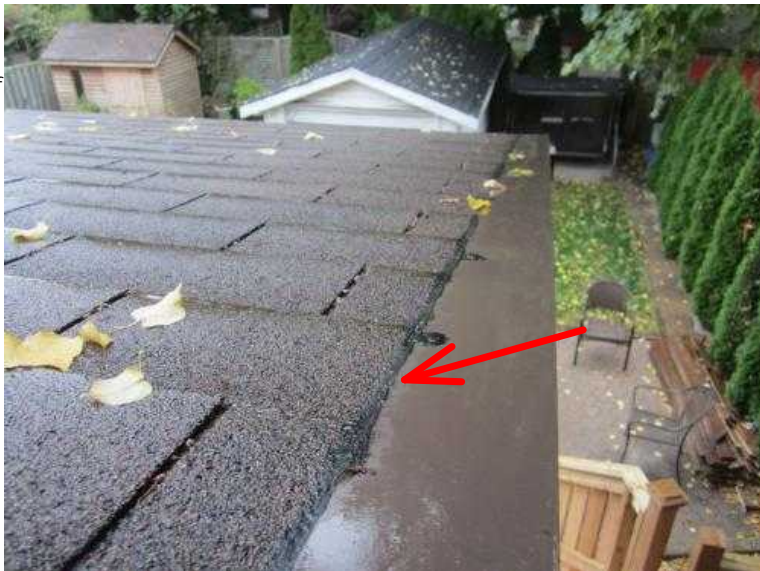
7. Acceptable, Improve Material: Asphalt shingle: Rake flashing is the flashing at the side edges of the roof. These flashings are installed above the shingles, but should be installed underneath them. As a result, ensure that you maintain the caulking at the edges. This will not have any material impact on roof longevity

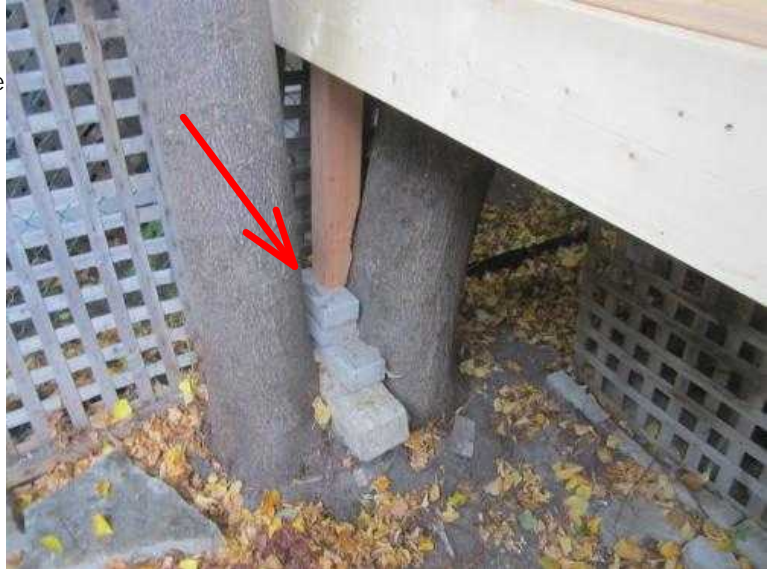
5. Acceptable, Improve **Deck: Wood:** Usually when a deck is attached to the house as this one is, the deck supports are concrete piers in sonotubes. Deck supported by deck-blocks, which float up and down with the soil level during frost heave - add lime screenings around them to try and direct water away and minimize soil saturation at the base. Where the deck is built over the base of a tree, the tree will eventually move and shift the deck post - monitor and repair as needed.

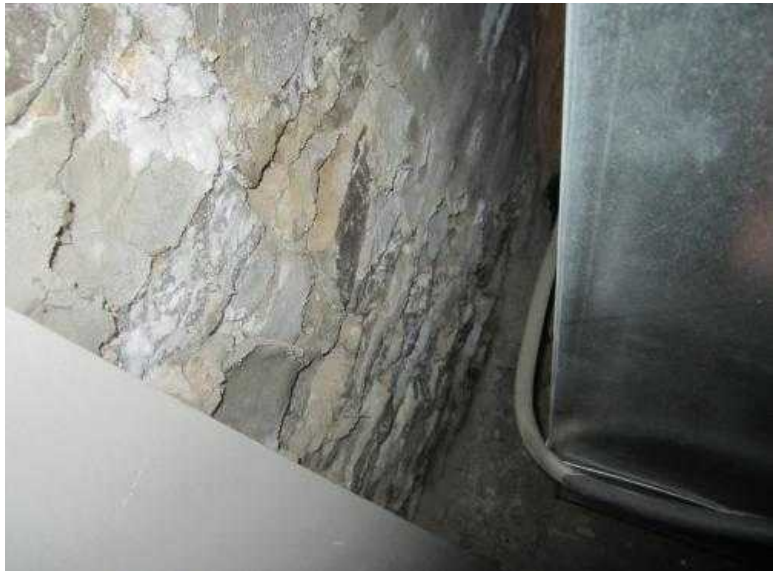
3. Acceptable Foundation: Stone: Stone foundations were originally designed to allow moisture through. Over time, owners filled joints with mortar and started using the basements for living or storage space. In a perfect world, the foundation would be fully exposed, tuckpointed, parged and sealed with waterproof membranes and/or paint. This is done in lieu of basement excavations (which are even more effective at preventing moisture entry) before finishing basements. Any finished areas with hidden structure must be disclaimed, as moisture damage is more probable over time.

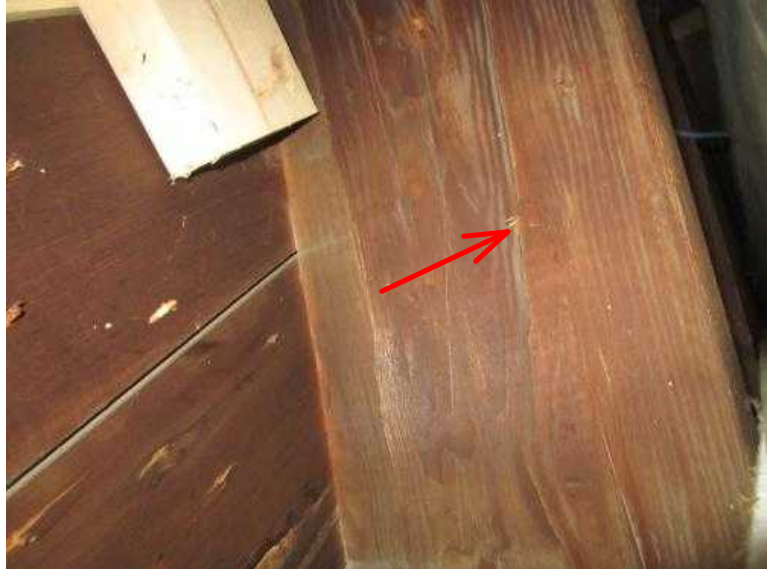
5. Acceptable Joists: 2x8: Typical - minor checking/cracking in joists. Monitor.

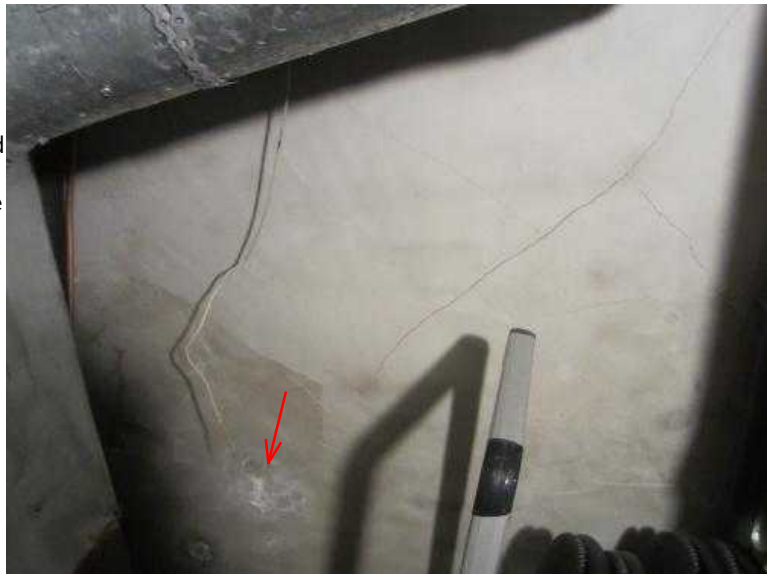
3. Acceptable Walls: Drywall, Parged, Metal framing: Minor amounts of efflorescence (white mineral salts) in parging which indicate moisture/humidity that has leached through. Typical old house condition. Suggest painting visible parged walls with DtyLok waterproofing paint (wee www.ugl.com - available at Rona)

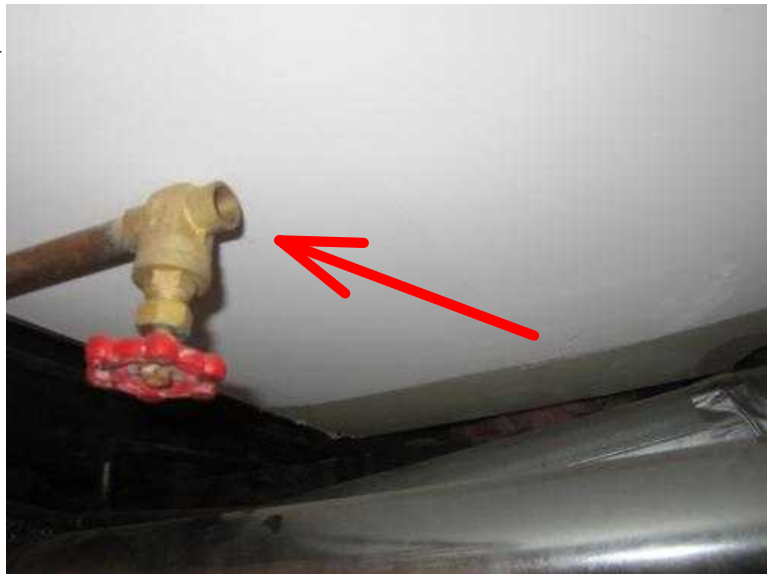
4. Acceptable, Improve Water Lines: Copper:
Note that the exterior water shutoff at the rear is not installed yet. A termination cap should be installed so that water cannot be accidentally discharged into the basement.

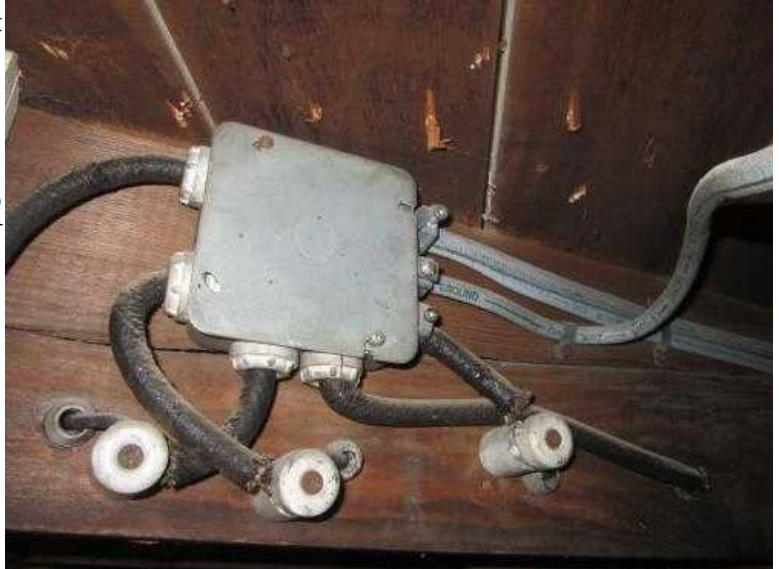
6. Acceptable Knob & Tube Wiring: Suspect removed: There was originally knob & tube wiring in this building, but there are no ungrounded circuits visible. The old wiring in the basement appears to be disconnected. Knob & tube wiring is ungrounded older wiring that has become an insurance issue. Although the wire itself is not unsafe (as per various regulatory bodies), it can be unsafe if altered improperly.
