Blueprint Building Inspections 60 Symons Street Toronto, ON M8V 1T9

Inspection Report

8 Patika Avenue Toronto, ON

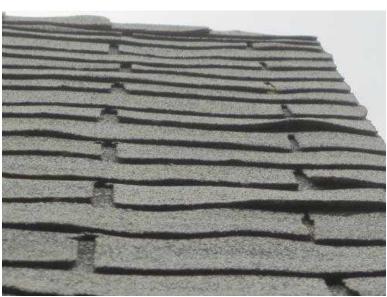
- 1. Restrictions: roof viewed from edge and ground, Roof pitch too steep to walk safely Roof Surface -
- 2. Method of Inspection: Ladder at eaves
- 3. Acceptable, Investigate Material: Asphalt

shingle: Typical wear and tear - expanded seams, edges wearing, minor edge curl, brittleness, granules wearing and some nails poking through. Expect replacement in next 2-3 years approximately, and possibly some spot repairs in the interim

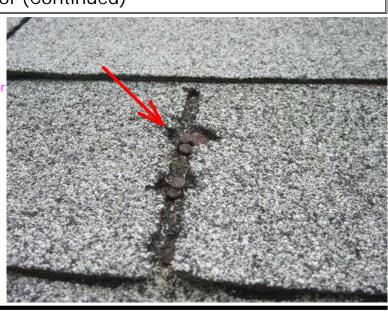
6. Tips We highly recommend a roof and flashing tune-up every 4-5 years as materials such as caulking deteriorate more quickly than other components of the roof. Due to the current condition, we recommend a roofer perform minor maintenance/repairs in the short term. At a minimum suggest the addition of caulking as required

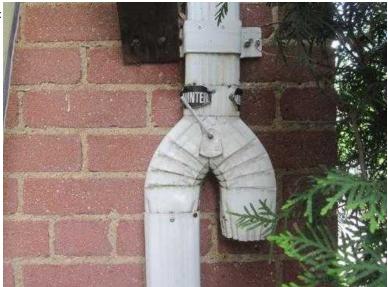
Leader/Extension: Extensions: Monitor the function of the downspout extensions in winter and during heavy rains to confirm that downspouts move water away from foundation. Rear downspout has a rain barrel configuration.

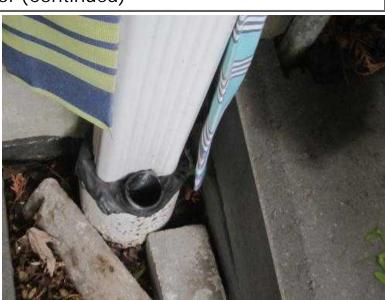
13. Improve

Leader/Extension: Underground pipes: In the City of Toronto, it is contrary to bylaws to allow roof drainage to discharge into underground pipe and then into the sewer system. Recommend disconnecting downspouts from underground drains to discharge onto soil 3-6 feet away from foundation, When downspouts discharge into the underground pipes, the water can spill into the surrounding soil, especially if the pipes are clay, angled or older. This water tries to enter the basement. Also, this water can add humidity at the interior base of the walls.

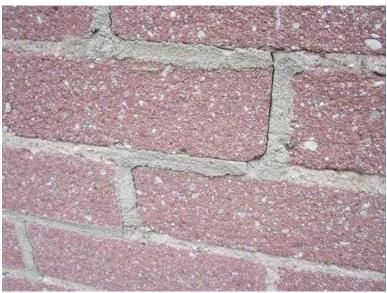
1st Floor Exterior Surface -

2. Acceptable Type: Brick: Minor mortar issues are typical of older homes. In this case there are a few mortar repairs that have been done and one or three that could be done in the next 2-5 years. No action required at this time.

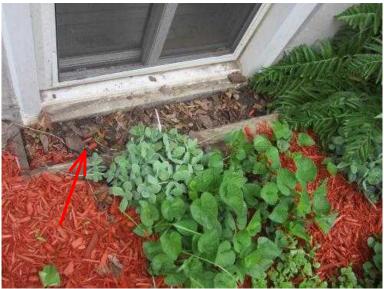
10. Improve

Window Wells Wood: Keep clear of debris/leaves and monitor drainage, improving the mini-window well if needed.

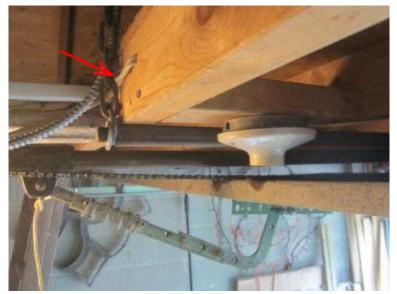
Electrical: 15 amp 3 prong receptacles, 110 volt lighting circuits: Non-GFCI circuit -recommend GFCI circuit be installed, Surface mounted, unprotected wire should be run through conduit to protect it. Relatively minor issues but they should be addressed. A licensed electrician is recommended to evaluate and estimate repairs

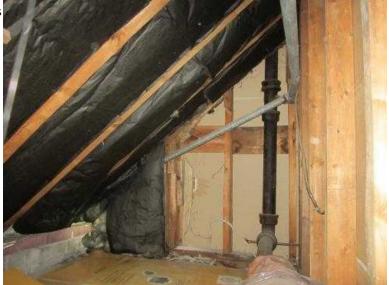
Front Attic -

- 1. Restrictions: 20% visible, Visible from front hatch only, Insulation. no access to upper attic or rear attic hatch
- 2. Method of Inspection: From the attic access

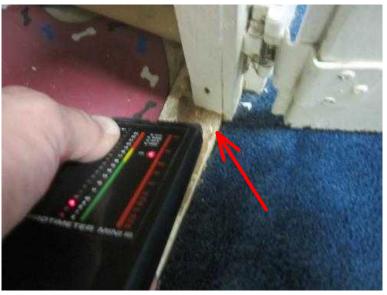
Laundry Tub: Plastic: Appears to be a minor leak under the laundry tub, at the front of the cabinet on the floor. Moisture readings in the wood were over 25%, indicating the leak is active. No obvious cause found during inspection. Monitor and repair as needed.

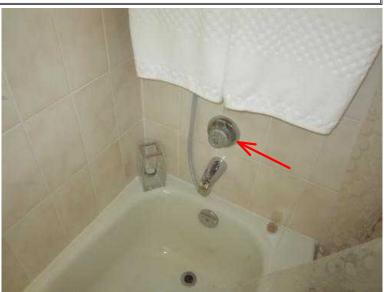
24. Defective Tub/Surround: Porcelain/enamel tub, Tile surround: Water does not operate as faucet is faulty. Suggest repair or replacement of faucet. Also, the window covering (California shutter) is restricted at the shower curtain bar (again a

minor point).
