Blueprint Building Inspections
60 Symons Street
Toronto, ON M8V 1T9

Inspection Report

11 Hemlock Avenue
Toronto, ON

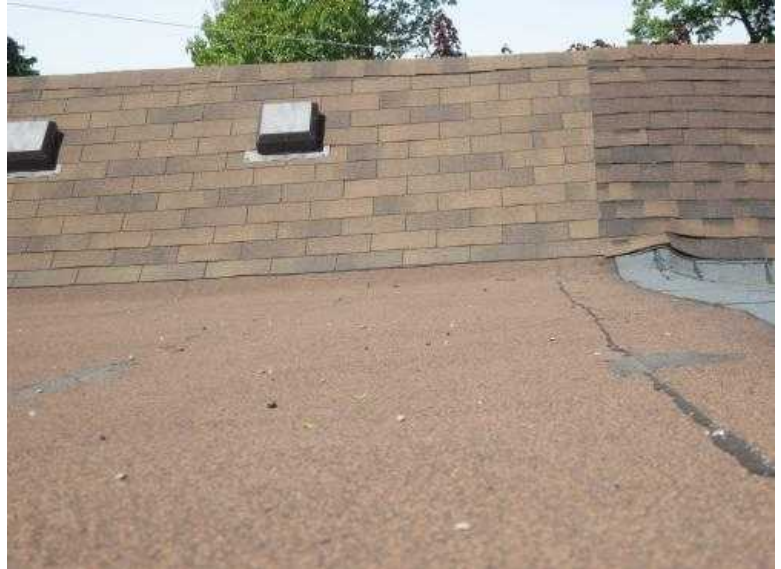
Back flat Roof Surface

6. Acceptable **Material:** Rolled roof material (Modified Bitumen): Continue to maintain as required. Granules have peeled in small areas, (possibly from physical abrasion when roof was done next door, and not likely to be repeated) but been maintained with a roofing cement. May require more tar application in 4-5 years.

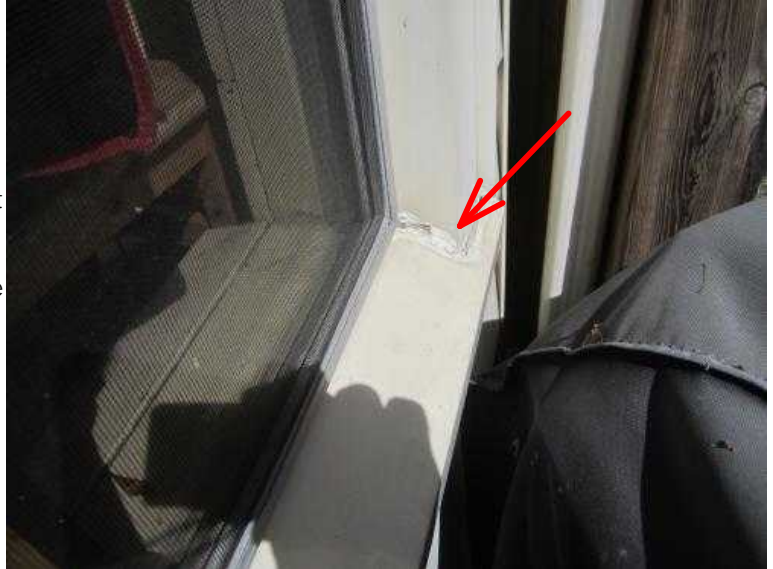
7. Acceptable, Improve Window Trim Metal clad wood: It is important to monitor and maintain exterior caulking and paint to ensure weather resistance. Paint and caulk should be evaluated at least annually and repaired as needed. Caulk is required now at the mudroom window trim - minor maintenance note

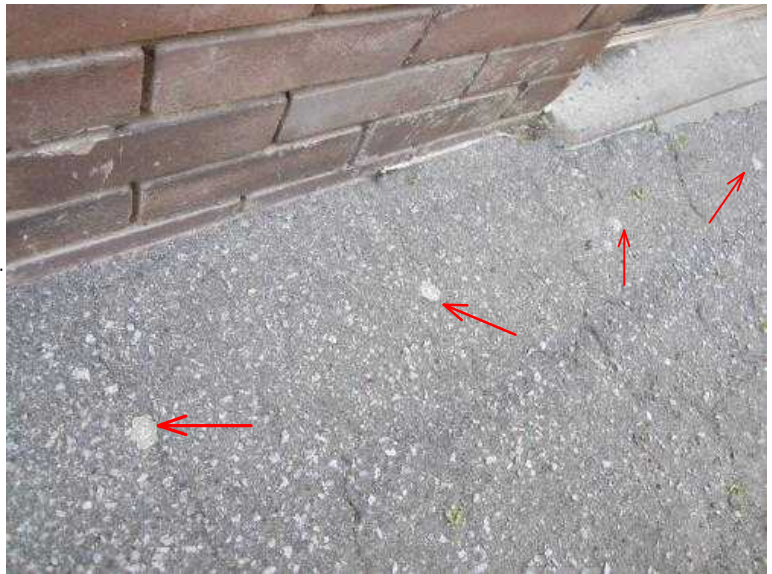
2. Acceptable Driveway: Asphalt: One of the telltale signs of termite treatment is a series of holes drilled in the asphalt every 12-16" in order to inject termiticide into the soil. These signs were visible in the asphalt driveway, which means that there has been previous termite treatment on this property. The treatment could possibly have been done as a preventative measure - there was no other evidence of any infestation or damage on the day of inspection.

Information note - Termites (subterranean kind) live in the ground and typically forage for old, rotted wood, which may be found in basements, exterior wall finishes or window frames, porches, decks, tree stumps or debris, or even garden dividers and retaining walls. They also can be found in cemeteries, along railway tracks, and wood piles. They require close wood to soil contact in order to access the wood they feed on. Since termites dry out when exposed to air, they

build sand coloured shelter tubes when they hit the open air. Any found shelter tubes should be broken - if termites are active, they will rebuild them. Any wood to soil close contact should be eliminated. Consult a pest control specialist for further inspection, treatment and advice.

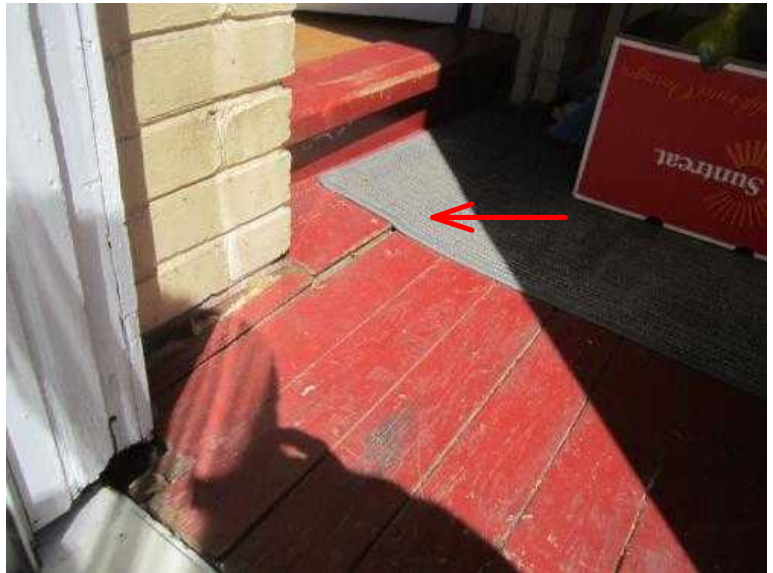
Mudroom Outbuilding

2. Acceptable Roof: Asphalt shingle
3. Investigate Floor: Wood: Floor has settled at threshold. Indicates that this older mudroom has not got a foundation that is permanent. If settlement re-occurs or continues, suggest looking under the mudroom and determining best method of stabilizing. Having said that, the mudroom is not insecure or immediately unstable.

4. Not Inspected Foundation: Not visible: Floor settled - foundation is likely lacking, as is common in these older add-on mudrooms.

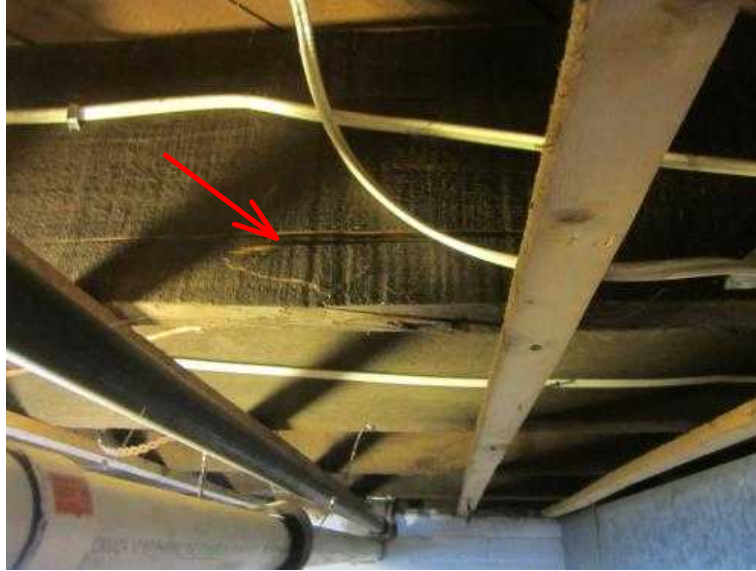
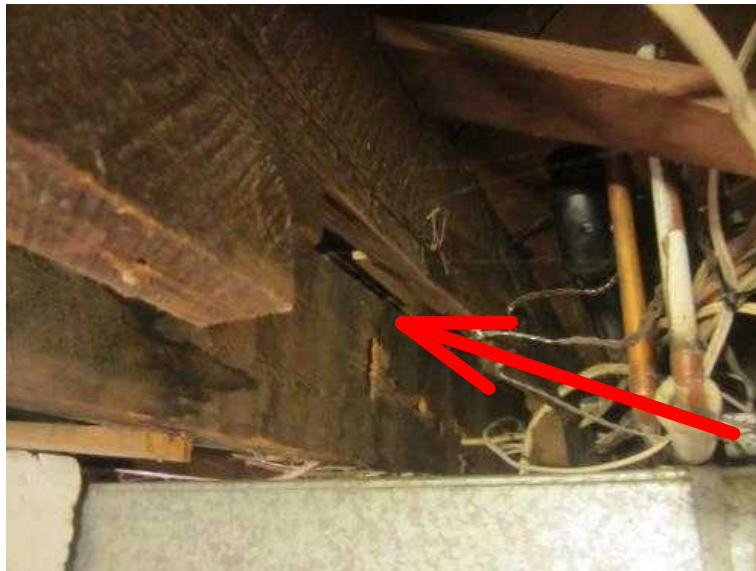
5. Acceptable Joists: 2x10: Typical old house issues - checking and cracking of joists and some minor settlement. Where joist was partially cut away under kitchen sink, monitor and consider "sistering" a new joist beside it to prevent future settlement. This would be considered a minor repair.

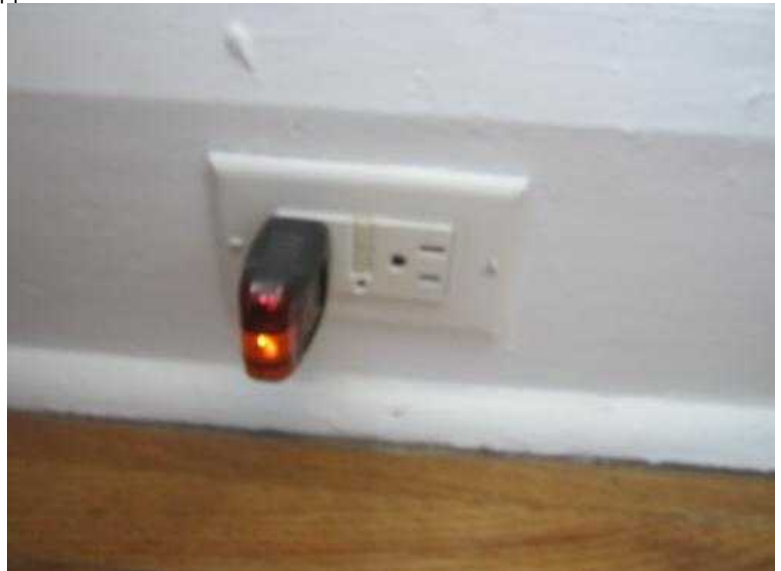
Although the wire itself is not unsafe (as per various regulatory bodies), it can be unsafe if altered improperly.

Generally, it is accepted that exposed knob & tube be replaced, and that ungrounded receptacles be made safe by grounding or GFCI installation. Most insurance companies charge a premium where knob & tube exists, or demand upgrades (partial or complete) within a set

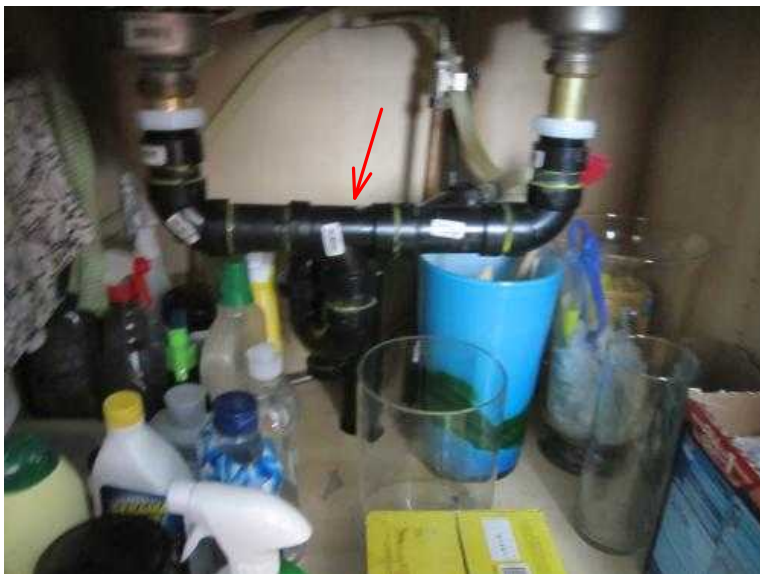
6. Acceptable, Improve Traps: Trap can be opened (locknuts): There is an incorrect drain configuration. The sideways T-fitting restricts the flow of water from the right bowl. This can cause water to come up into the left bowl from the drain. Amateur work - we consider a correctly installed trap and drain to be more reliable. A licensed plumber recommended to replace the trap. Suspect trap is poorly vented (long run to stack connection - verify with a plumber). See plumbing section on venting. Repairs are only necessary in most cases when problems with drainage or odours arise.
