Blueprint Building Inspections 60 Symons Street Toronto, ON M8V 1T9

# Inspection Report

4 Hunthill Court Toronto, ON

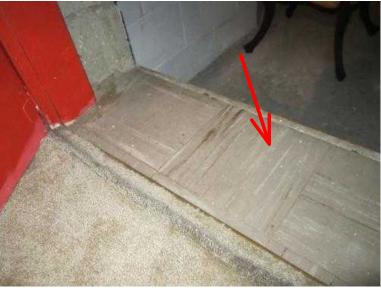
- 1. Restrictions: See restrictions for Structure. Note sauna is outside the expertise of the inspector and thus the scope of inspection.
- 2. Acceptable Ceiling: Drywall or plasterboard
- 3. Acceptable Walls: Paneling, Drywall or plasterboard
- 4. Acceptable Floor: Carpet, Concrete, Tile: Tiles at crawlspace entrance may, based on the era of home, contain asbestos. If removal is ever undertaken, then have the tiles tested to confirm they are asbestos-free. There is no risk to health or home as constituted.

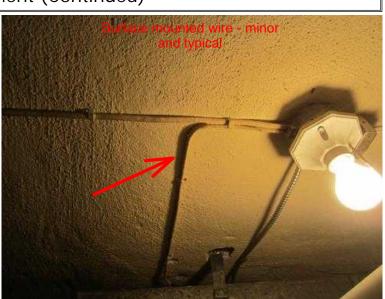
6. Acceptable, Improve Electrical: 15 amp 3 prong receptacles, 110 volt lighting circuits, 15 amp GFCI: Surface mounted wire should be protected from physical damage, but usually is not in most homes of this era. A licensed electrician is recommended to evaluate the need for repairs and estimate repair cost

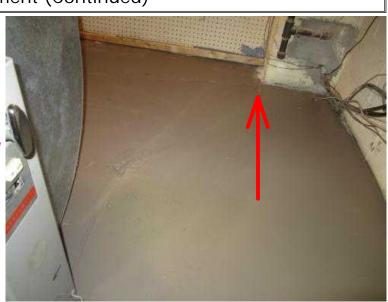
13. Marginal Reading: 30%: Highest reading was located in the SE corner of the unfinished furnace area, at the floor. Monitor the area, as no ill effects in this location were evident. Moisture readings below 20% are desirable, because mold, mildew and fungi start to grow (especially on wood or cellulose based products) at around the 20% mark. During wet spring conditions, moisture levels can rise. Monitor exterior drainage to ensure that water runs away from foundation.

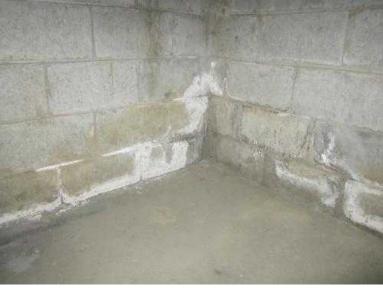
- 7. Improve Insulation: Absent: Insulation on the exterior walls and the floor, such as styrofoam, would be of benefit
- 8. Investigate Moisture Penetration: Visible at the base of walls: White efflourescence present indicates humidity/dampness in the walls. Monitor and improve exterior drainage at ground level and see suggestions for ventilation improvements above. Note that this is a common situation in crawlspaces the staining in evidence is not of sufficient degree to cause alarm. Consider as an option, painting the walls with DryLok waterproofing paint to lower the transfer of humidity/dampness through the block walls.

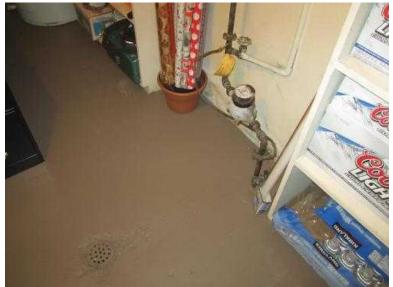
- Not Present Item not present or not found.
- 1. Restrictions: Throughout all buildings, wall and ceiling finishes restrict complete evaluation hidden defects usually go undetected during inspections
- 2. Acceptable Main Water Shutoff: Basement, Front of building

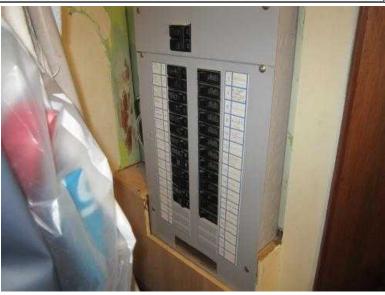
8. Acceptable Manufacturer: Commander

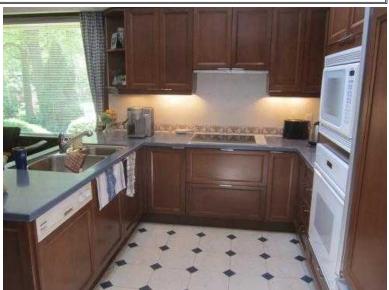
2. Acceptable Ventilation: Over the stove fan - vented to exterior
