Blueprint Building Inspections
60 Symons Street
Toronto, ON M8V 1T9

Inspection Report

81 College View Avenue
Toronto, ON

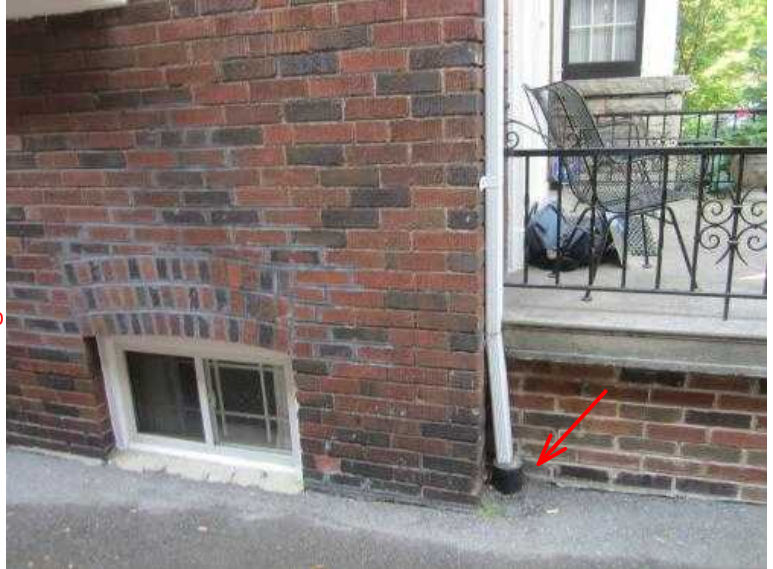
19. Defective

Leader/Extension:
Underground pipes: **When roof water runs into underground pipes, the possibility exists for water to spill through any openings into surrounding soil. This water puts hydrostatic pressure on the foundation and can enter the basement. Also, in the City of Toronto, it is contrary to bylaws to allow roof drainage to discharge into underground pipe and then into the sewer system. Recommend disconnecting downspouts from underground drains to discharge onto soil 3-6 feet away from foundation.**

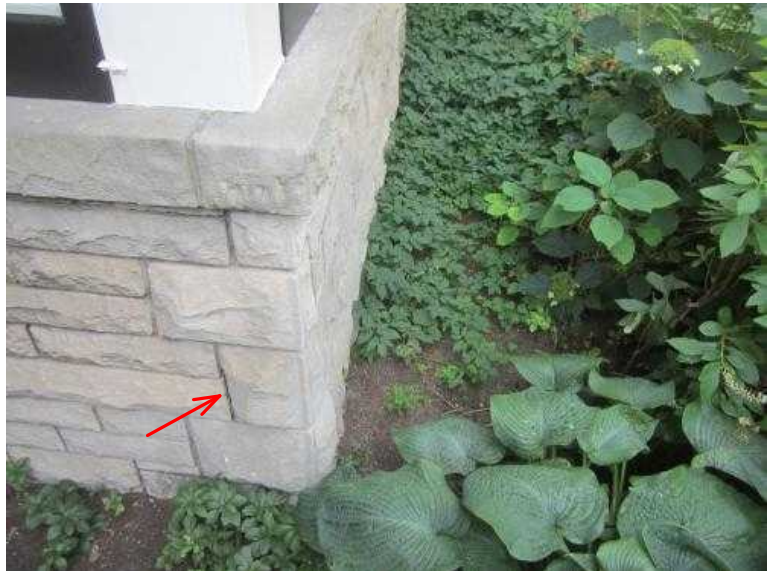
3. Acceptable, Improve Type: Stone veneer:
Tuckpointing required where mortar has cracked, suggest within next few years

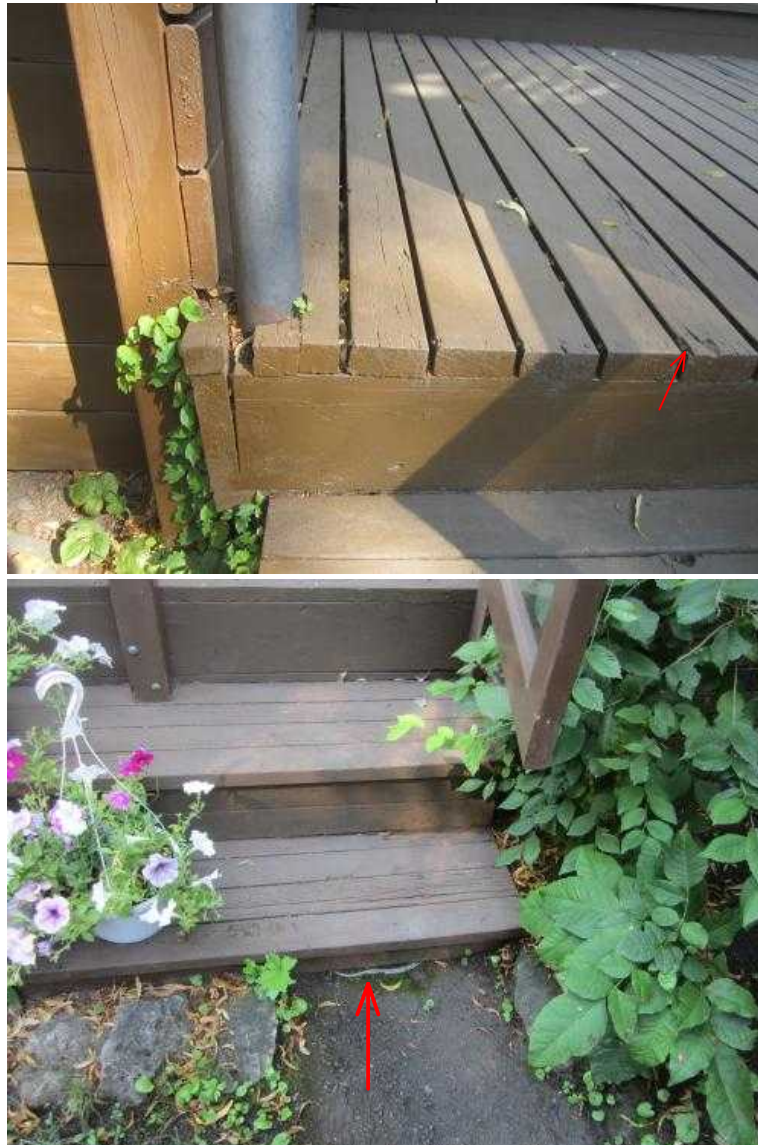
5. Acceptable, Investigate Deck: Stained wood: Access under deck is restricted. Cannot inspect structure, grading or any aspects under deck. There is some minor rot visible but generally in a reasonable condition. Estimated lifespan of deck is 5 or so more years. Protect wire that is visible at bottom step.

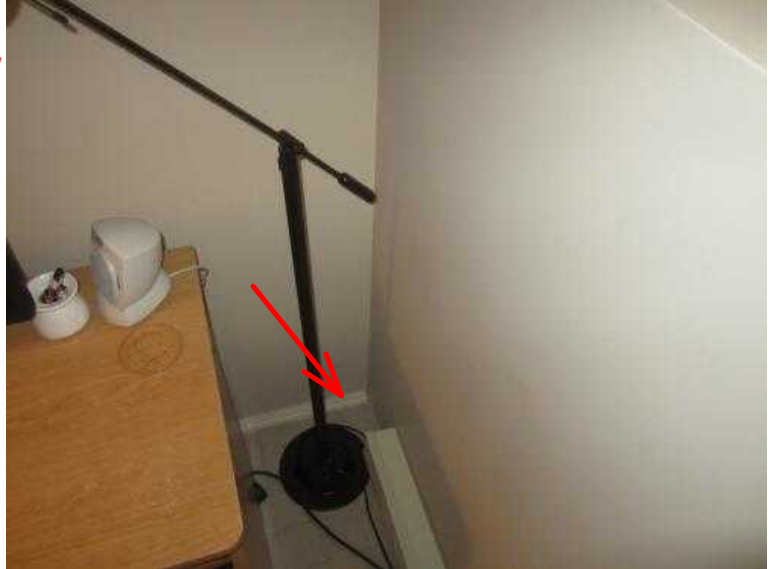
12. Defective

Reading: 45%: Moisture readings below 20% are desirable, because mold, mildew and fungi start to grow (especially on wood or cellulose based products) at around the 20% mark. During wet spring conditions, moisture levels can rise. Monitor exterior drainage to ensure that water runs away from foundation. Disconnect downspouts at exterior this location and caulk the joint between driveway and house. It is possible that there is a mortar defect or similar small entry point that is allowing moisture in behind the drywall. Dealing with the exterior source is one step, but the conditions behind the drywall are conducive to microbial growth.

The drywall is firm and no microbial growth is in evidence. Nonetheless, recommend removal of at least the bottom 16" by 16" corner of drywall to completely confirm the extent of repair requirements. It is also duly noted that moisture readings 3 feet away from the corner were below 20%, indicating that this is likely a localized issue to the corner.

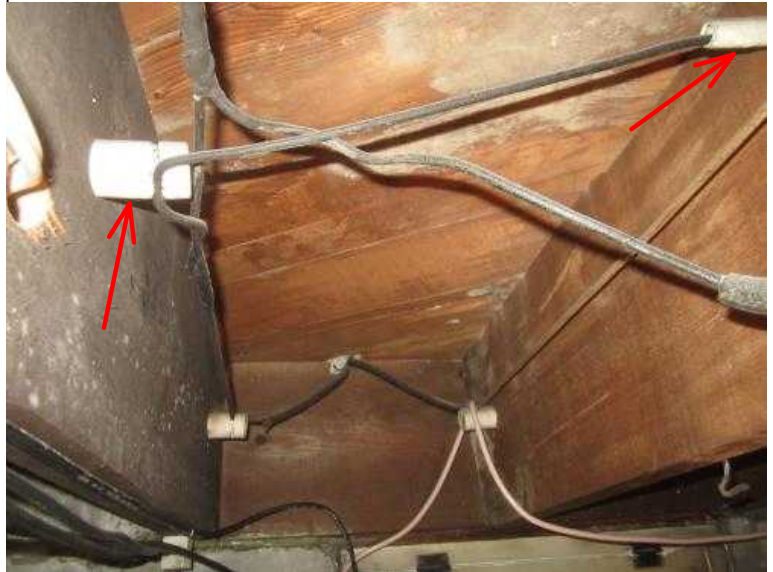
5. Investigate Knob & Tube Wiring: Present:

Knob & tube wiring is ungrounded older wiring that has become an insurance issue. Although the wire itself is not unsafe (as per various regulatory bodies), it can be unsafe if altered improperly. Generally, it is accepted that exposed knob & tube be replaced, and that ungrounded receptacles be made safe by grounding or GFCI installation. This means that the exposed basement wiring (see photo) will need to be replaced. Also, several ungrounded receptacles were found, so those will also need to be addressed. Most insurance companies charge a premium where knob & tube exists, or demand upgrades (partial or complete) within a set time frame. Contact your insurance carrier to determine any conditions they might impose. They may simply ask for an inspection from the ESA (Electrical Safety Authority).

6. Acceptable, Investigate Conductor Type: BX (armoured cable), NMD-90 (Romex), NMD-3 or 7 (Loomex), Knob and tube: Suggest rewiring at least partially, GFCI installation or other measures as recommended by licensed electrician

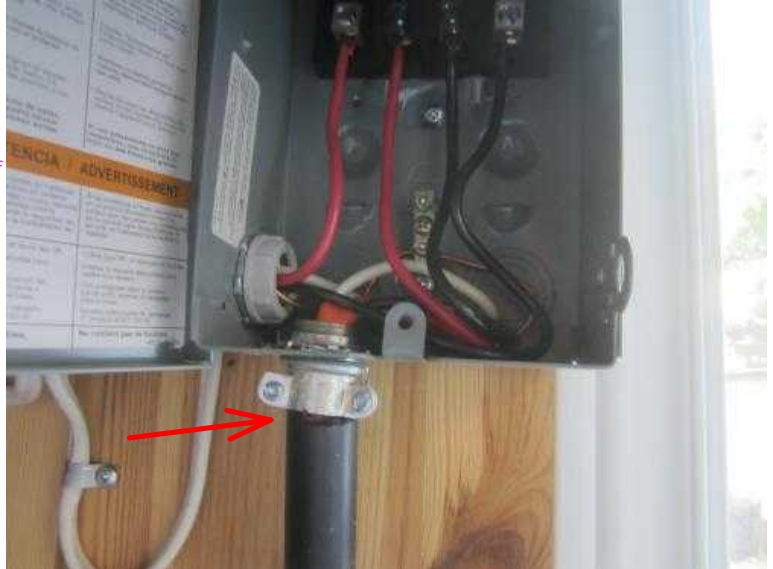
13. Acceptable Manufacturer: Square D:
Conduit connections/fittings are loose. Not technically the correct conduit but functional. Two screws were added to the panel cover to keep it in place, as one of the manufacturer's bolts was stripped. Evaluation by a licensed electrician is recommended

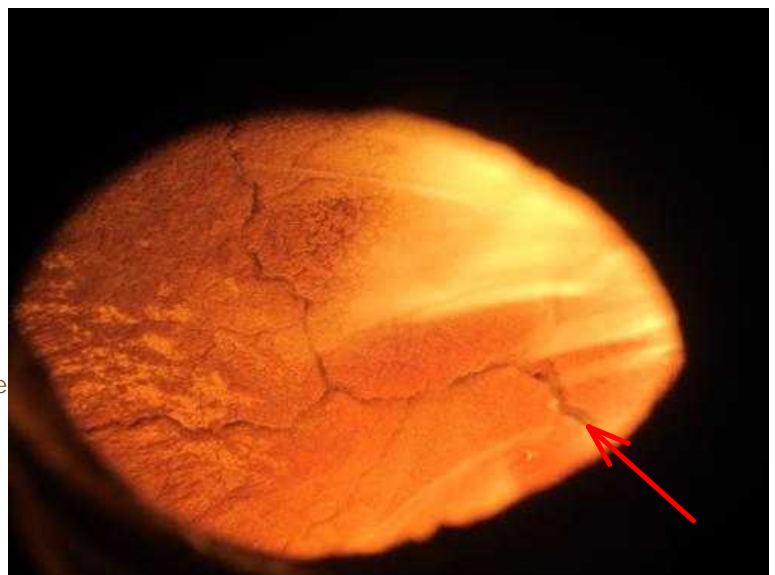
6. Investigate Oil Burner Box: Typically restricted: An oil burner box is the area where the oil is fired to produce heat. It is lined with a refractory heat -resistant material, and over time, cracking will occur. Part of the annual inspection, which we recommend, would be a professional evaluation of this area. There is some cracking in the refractory material at this time, which means repairs to this area will likely be required at some point in the next year or so.

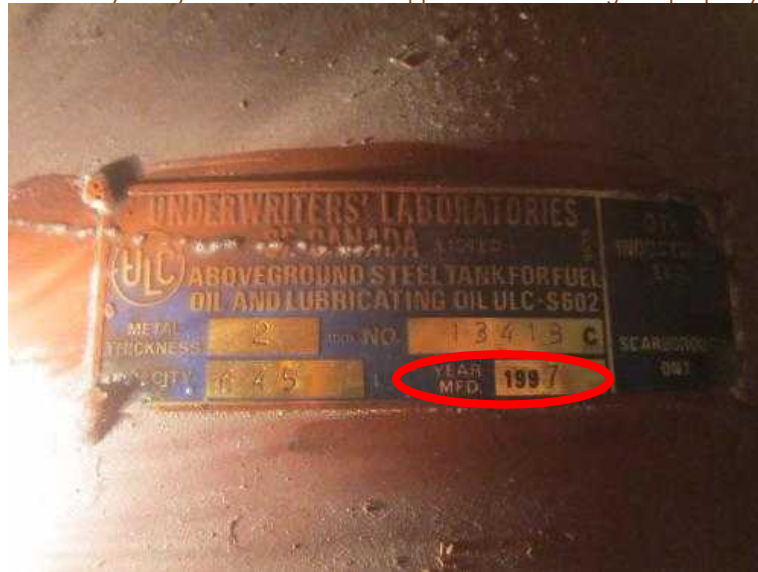
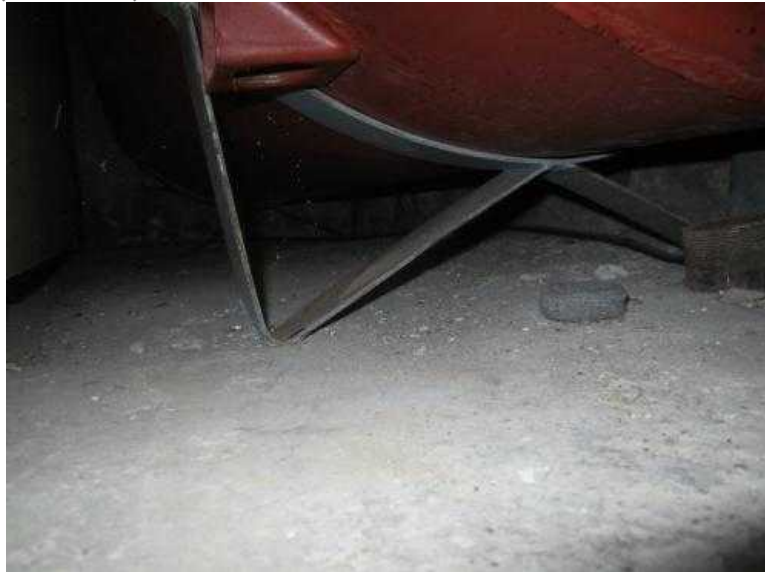
Fuel Tank: (continued)

- 14. Tank Location: Front NW corner
- 15. Investigate Fuel Tank: Metal (restricted by storage): No oil smell noted at the tank, nor are there oil stains, as shown in photo. Keep in mind that insurance companies can request replacement of the oil tank - they used to do so at the 25 year mark but now it is more common to replace the tank at the 15 year mark. This tank is 16 years old so this is a real possibility. Oil delivery companies are expected to inspect the tank every two years - ensure this happens while owning the property.

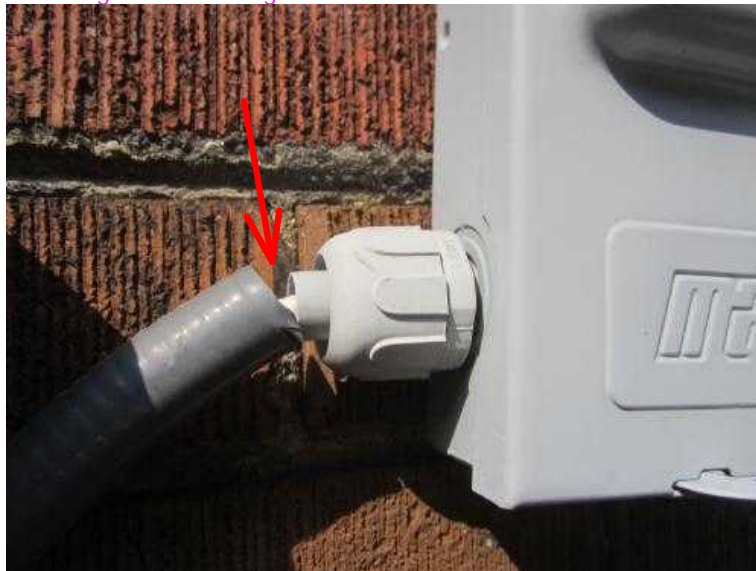
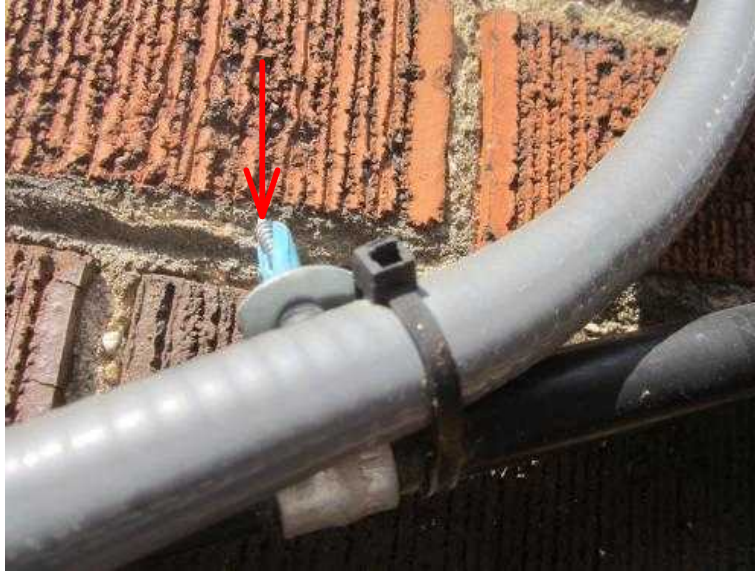
Electrical Disconnect: (continued)

10. Acceptable Refrigerant Lines: Low pressure and high pressure
11. Marginal Electrical Disconnect: Exterior weatherproof box: *Minor: Wire in conduit has loosened from wall, and as a result the conduit connections/fittings are loose - water will enter the conduit, possibly running into the house. Also, the exposed wiring can break down from exposure to exterior elements. Re-secure the fittings and mountings.*
