Blueprint Building Inspections
60 Symons Street
Toronto, ON M8V 1T9

Inspection Report

23 Carnarvon Avenue
Toronto, ON

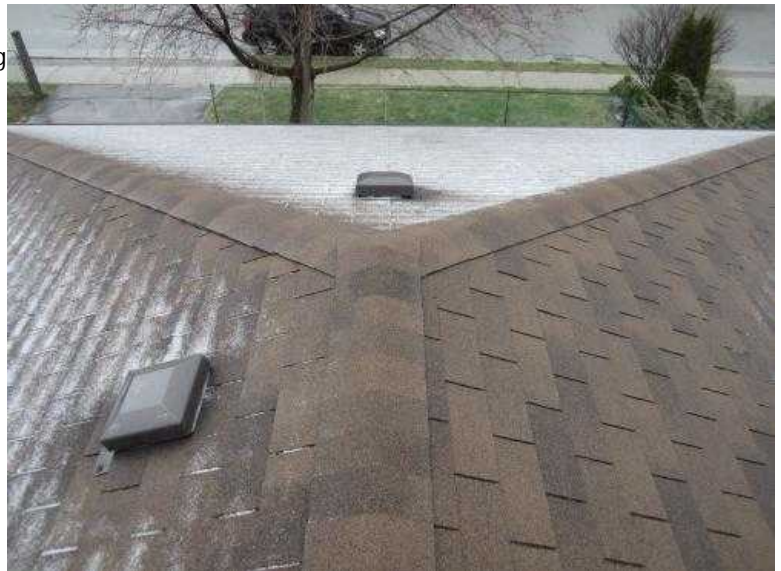
4. Acceptable Material: Asphalt shingle:
Typical wear and tear - expanding seams, granules loosening, edges wearing, commencement of brittleness. Expect replacement within next 3-5 years approximately

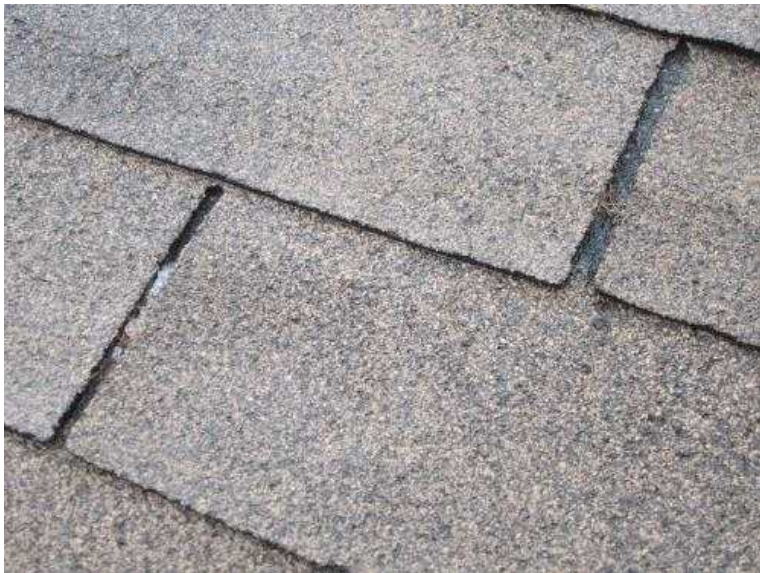
6. **Approximate Age:** 10-12 years old, in last third of typical life cycle: Most roofs are designed to last 15 years. Note that the age estimate is based upon the appearance of the shingles. They may be older or younger, but the wear patterns indicate the age that was recorded by the inspector. Expect replacement in next 3-5 years, as leak probability increases

7. **Tips** We highly recommend a roof and flashing tune-up every 3-5 years as materials such as caulking deteriorate more quickly than other components of the roof.

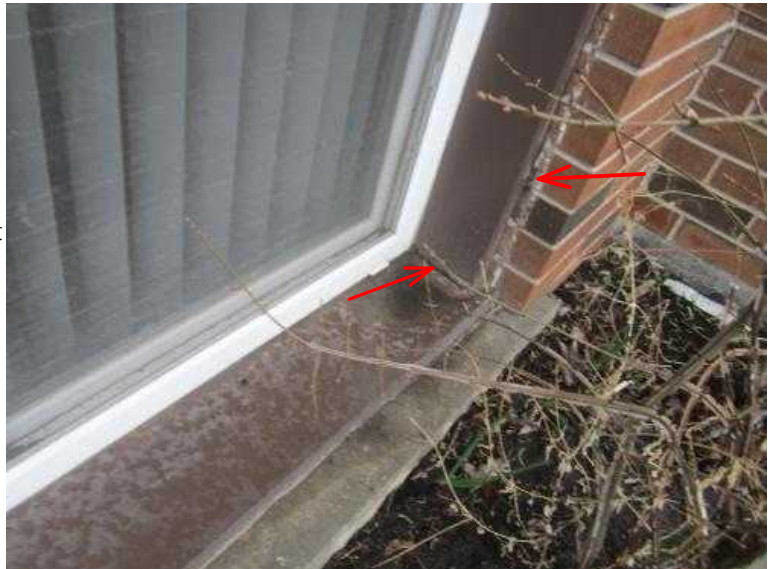
3. Acceptable Window Materials Plastic
4. Acceptable Window Operation Sliders
5. Acceptable Thermal Characteristics Thermal Pane
6. Acceptable, Improve Window Trim Metal clad:

Maintenance required: recaulk where joints are opening. It is important to monitor and maintain exterior caulking to ensure weather resistance. Caulk should be evaluated at least annually and repaired as needed.

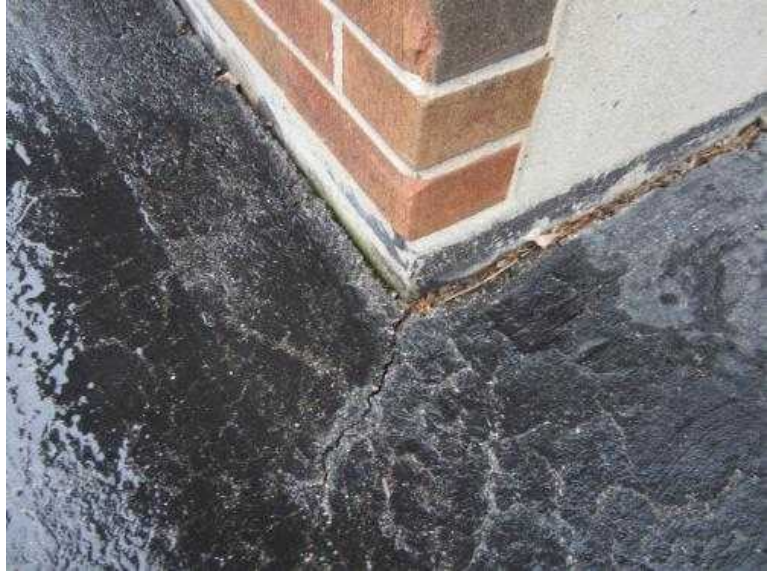
1. Acceptable, Improve Driveway: Asphalt:
Caulk joints between hard surfaces and walls.

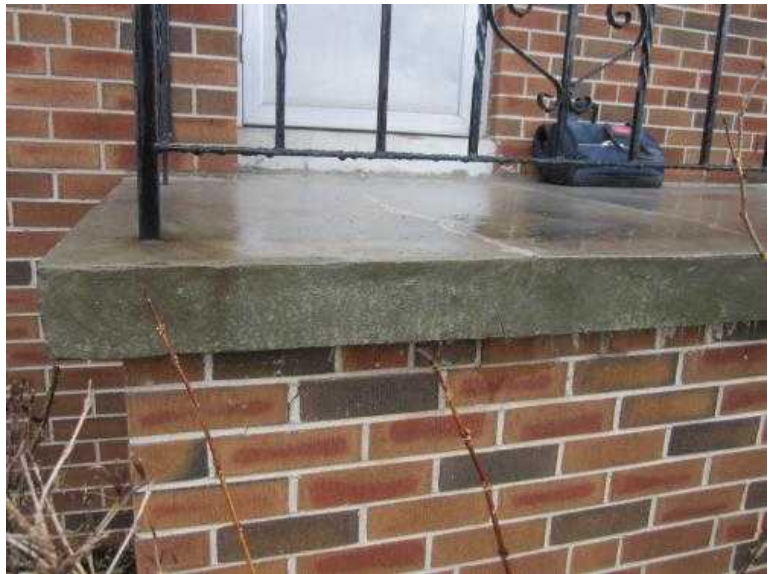
2. Acceptable Porch: Concrete, Brick: Minor mortar crack on front porch - monitor and repair if changes are noted

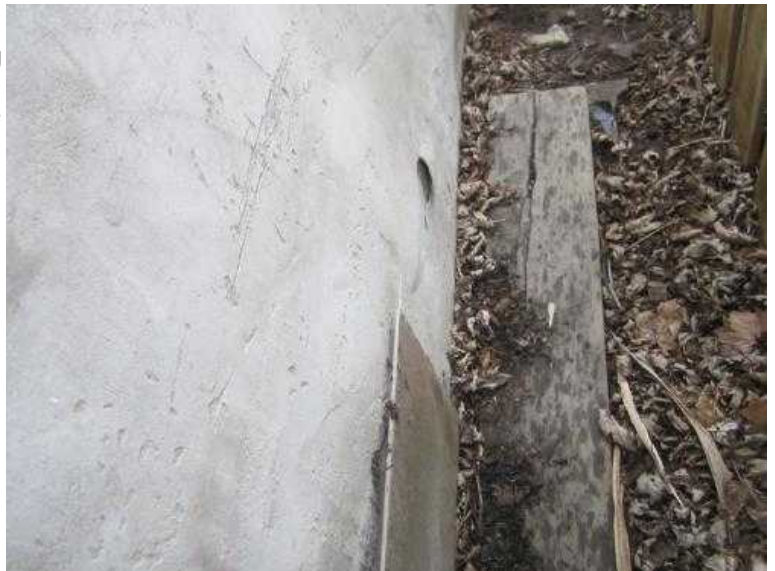
2. Type of Structure: Detached Car Spaces: 2
3. Acceptable Garage Doors: Metal
4. Acceptable Door Operation: Manual
5. Improve Exterior Surface: Brick, Parged coating: Some peeling of parging near the ground at the NW corner of the garage - minor repair to the surface recommended to prevent water damage.

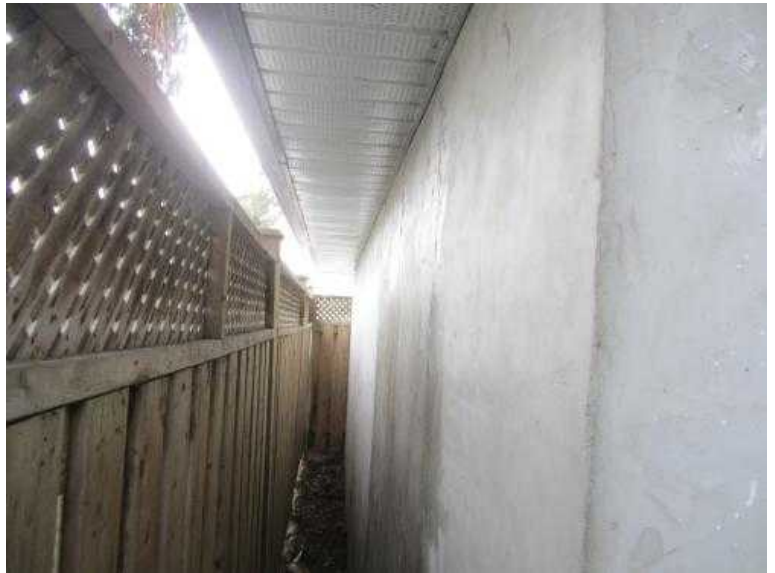
- 6. Acceptable Roof: Asphalt shingle
- 7. Acceptable Roof Structure: Rafter
- 8. Acceptable Ceiling: Exposed framing
- 9. Acceptable Walls: Block, Parged
- 10. Acceptable Floor/Foundation: Concrete: Some cracking and lifting from moisture and freeze/thaw cycles but not necessary to repair. Caulk at joint with driveway, similar to caulking the joint between the driveway and the house foundation. This driveway crack filler or caulk is used to keep moisture from entering.
- 11. Not Present Electrical: None
- 12. Investigate Gutters: Aluminum: Possible eavestrough leak at back of garage, which can eventually cause damage to the wall

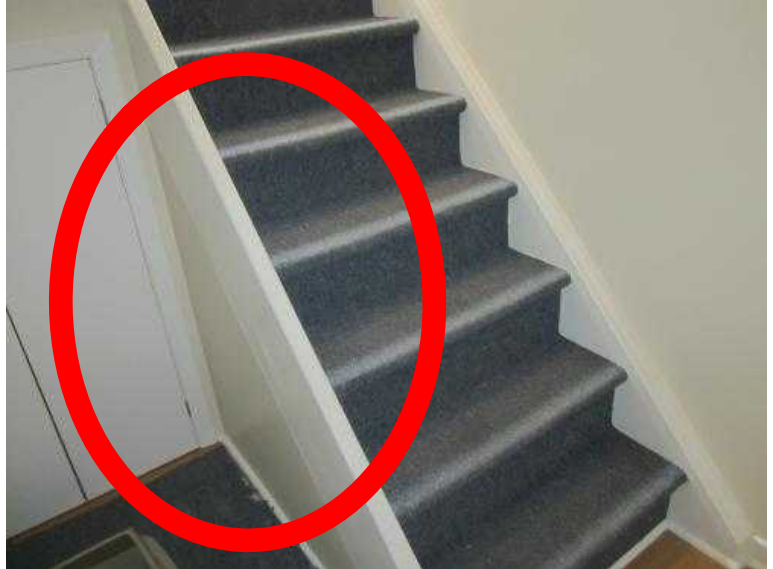
12. Defective Handrails No railing: **Missing railing, Liability issue and safety hazard that should be addressed in the short term**

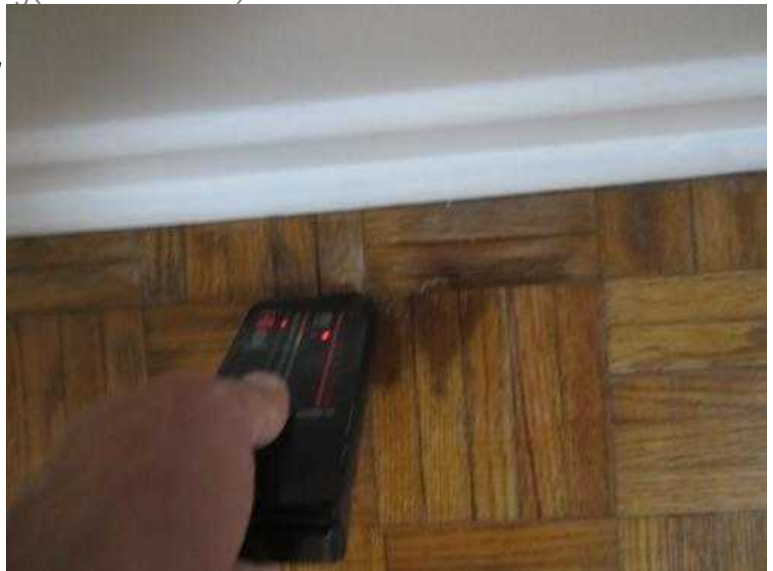
Peaks (in hardwood on floor) Invasive Testing(Moisture Probe)

14. Acceptable Reading: 21%: Moisture readings below 20% are desirable, because mold, mildew and fungi start to grow (especially on wood or cellulose based products) at around the 20% mark. During wet spring conditions, moisture levels can rise. Monitor exterior drainage to ensure that water runs away from foundation.

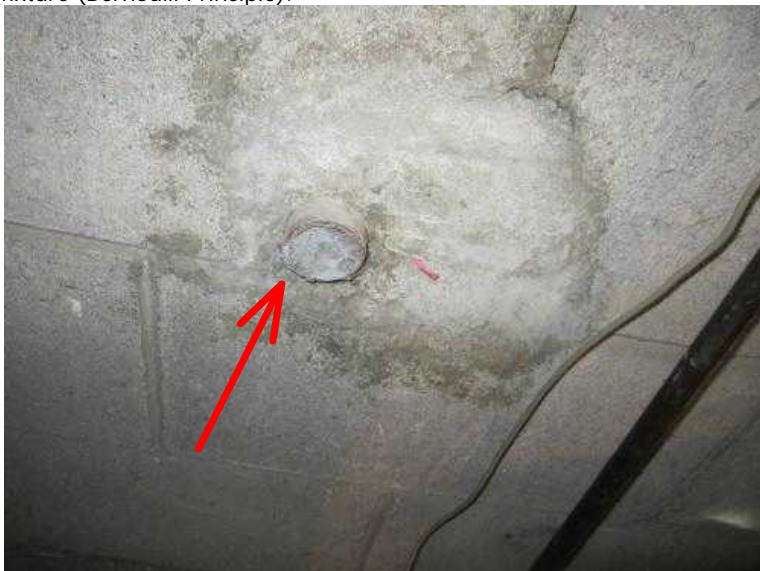
7. Acceptable, Investigate Gas Service Lines:
Black pipe, Copper: The pipe coming through the wall and filled with concrete is right in the area of the exterior gas meter, so suspect the gas meter was originally inside the house and that this dates back to that time.

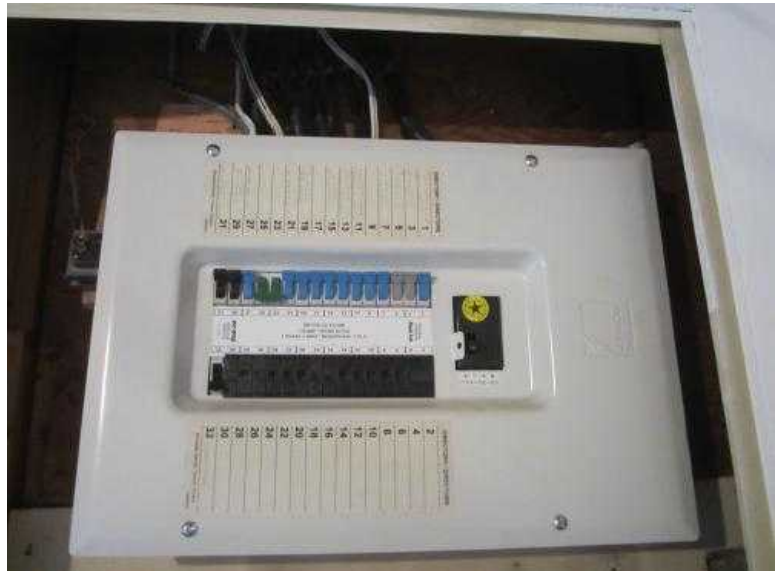
Basement Electric Panel

8. Acceptable Manufacturer: FPE (Federal Pioneer)

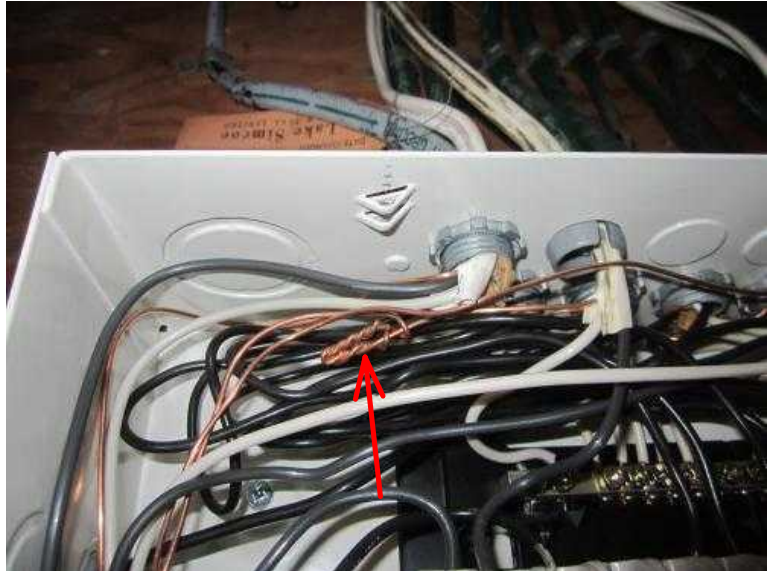
- 10. Acceptable Main Disconnect Size: 100 Amps
- 11. Acceptable Breakers: 15, 30, 40 amps
- 12. Is the panel bonded? Yes Ground wires in the panel are twisted together, which is a dated practice and no longer in use. If an electrician is onsite doing any other work in the future, have them check the ground connections in the panel and repair as needed.

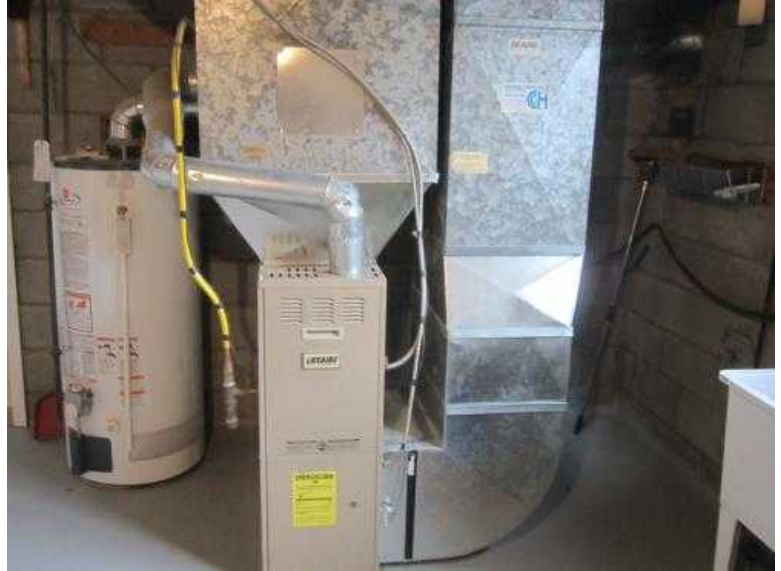
2. Acceptable Heating System Operation:
Appears functional: Consult a heating technician to develop an annual maintenance program to maximize the life of the unit.
Average life span of a furnace is 20-25 years.

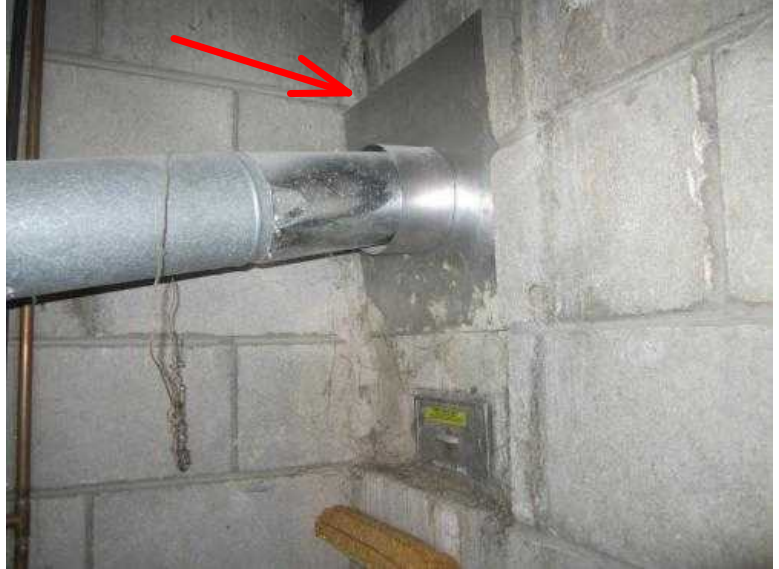
12. Investigate Flue Pipe: Metal: Flue pipe fitting is not flush with wall but still appears sound and is likely acceptable, but confirm this with your heating contractor when doing annual maintenance.
