# Inspection Report

15 Canterbury Crescent Etobicoke, ON

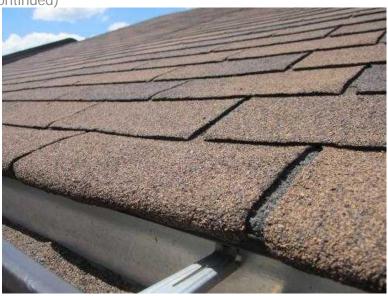
- 3. Type: Gable, Shed
- 4. Approximate Age: 11-12 years, (in last third of life cycle): Most roofs are designed to last 15 years. Note that the age estimate is based upon the appearance of the shingles. They may be older or younger, but the wear patterns indicate the age that was recorded by the inspector.
- 5. Tips We highly recommend a roof and flashing tune-up every 3-5 years as materials such as caulking deteriorate more quickly than other components of the roof.

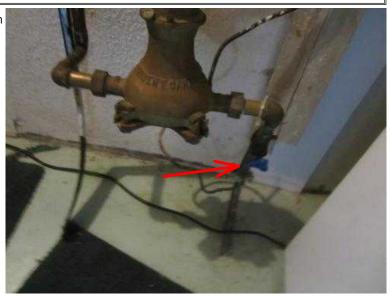
3. Acceptable Main Water Shutoff: Basemen

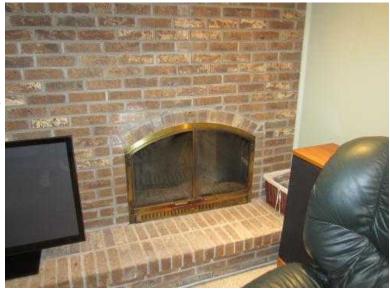
Brick: Standard note: Fireplace and components should be cleaned and inspected by a certified technician prior to use. Glass doors are a positive because they reduce heat loss up flue.

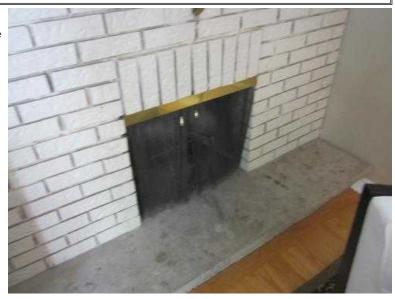
Brick: Standard note: Fireplace and components should be cleaned and inspected by a certified technician prior to use, Suggest use of glass fireplace doors to minimize heat loss up
