Blueprint Building Inspections
60 Symons Street
Toronto, ON M8V 1T9

Inspection Report

114 Beresford Avenue
Toronto, ON

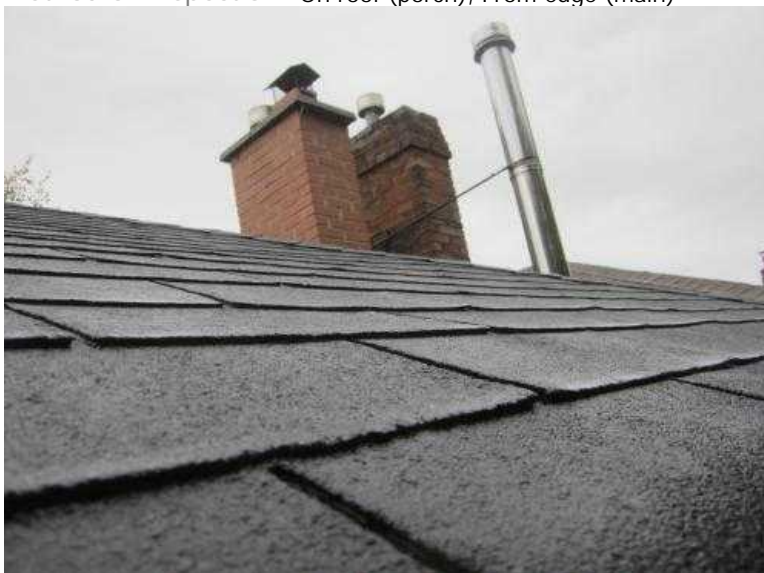
Porch, Main Roof Surface

2. Method of Inspection: On roof (porch), From edge (main)

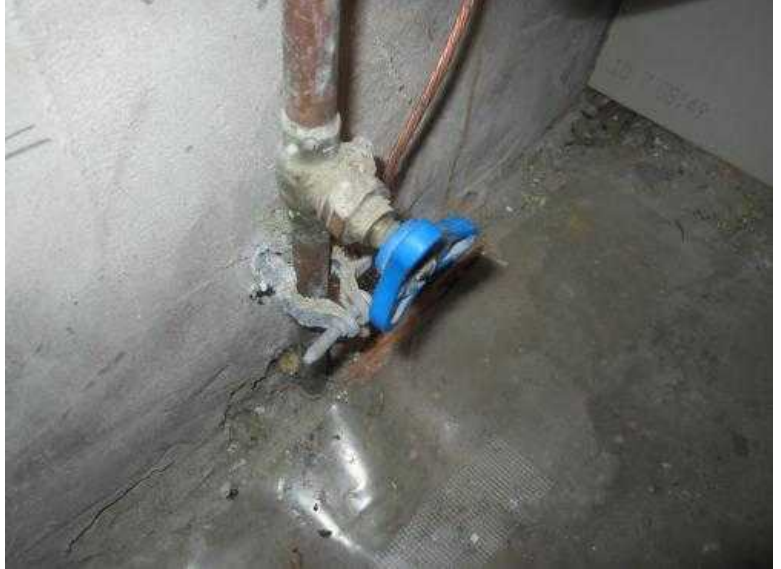
3. Acceptable Main Water Shutoff: Basement

4. Acceptable, Improve Water Lines: Copper:
Note that the exterior water shutoff at the rear is not installed yet. A termination cap should be installed so that water cannot be accidentally discharged into the basement.
