Blueprint Building Inspections
60 Symons Street
Toronto, ON M8V 1T9

Inspection Report

11 Hemlock Avenue
Toronto, ON

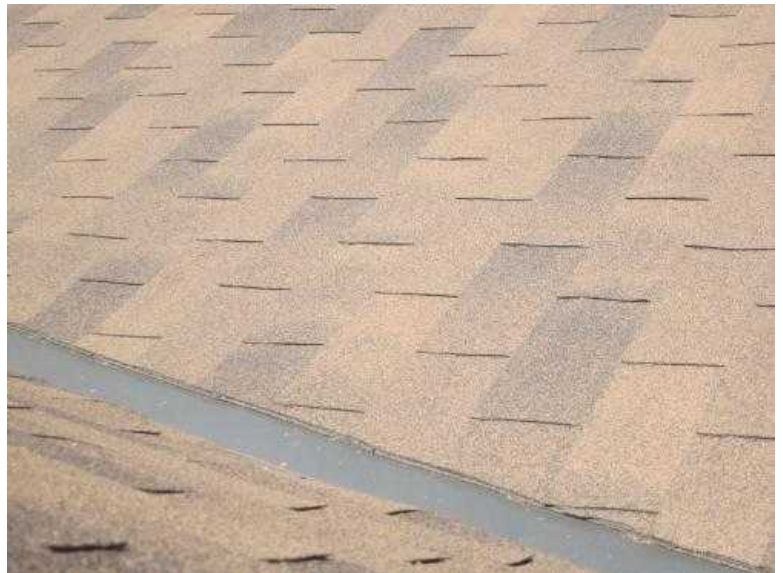
Main Roof Surface

1. Method of Inspection: On roof

2. Acceptable Material: Asphalt shingle
3. Type: Gable
4. Approximate Age: Newer (0-5 years): Most roofs are designed to last 15 years.

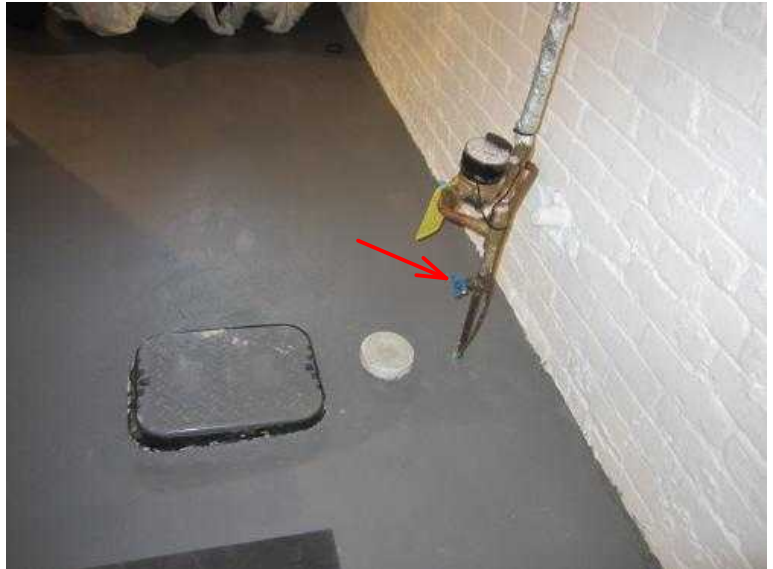
1. Restrictions: Throughout all buildings, wall and ceiling finishes restrict complete evaluation - hidden defects usually go undetected during inspections
2. Acceptable Service Line: Copper
3. Acceptable Main Water Shutoff: Basement

4. Acceptable Water Lines: Copper
5. Acceptable Drain Pipes: ABS, Cast iron, CPVC
