Blueprint Building Inspections
60 Symons Street
Toronto, ON M8V 1T9

Inspection Report

81 College View Avenue
Toronto, ON

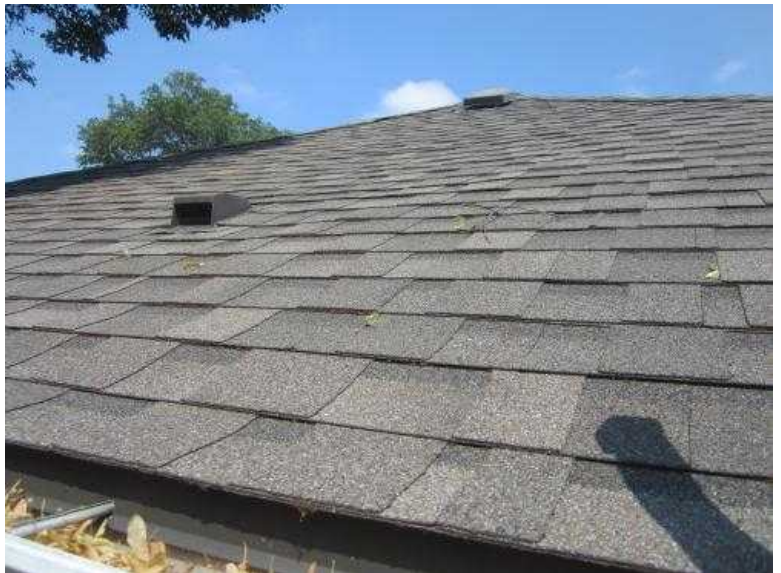
3. Acceptable Material: Asphalt shingle:
Showing little wear.
Keep trees well trimmed away
from roof.

5. Approximate Age: Newer (0-5 years): Most roofs are designed to last 15 years, but suspect this roof has a design life of 20 or more years. Note that the age estimate is based upon the appearance of the shingles. They may be older or younger, but the wear patterns indicate the age that was recorded by the inspector.

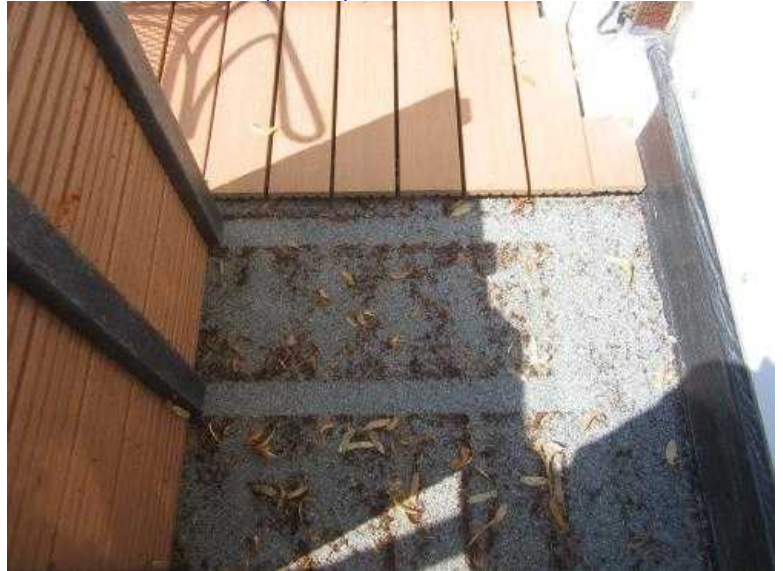
8. Acceptable Material: Rolled roof material (Modified Bitumen): Most flat roofs are designed to last 20 years

10. Approximate Age: Newer (0-5 years): Suspect this roof has a design life of 20+ years. Age estimate may be less than accurate in this case because the roof was not completely visible

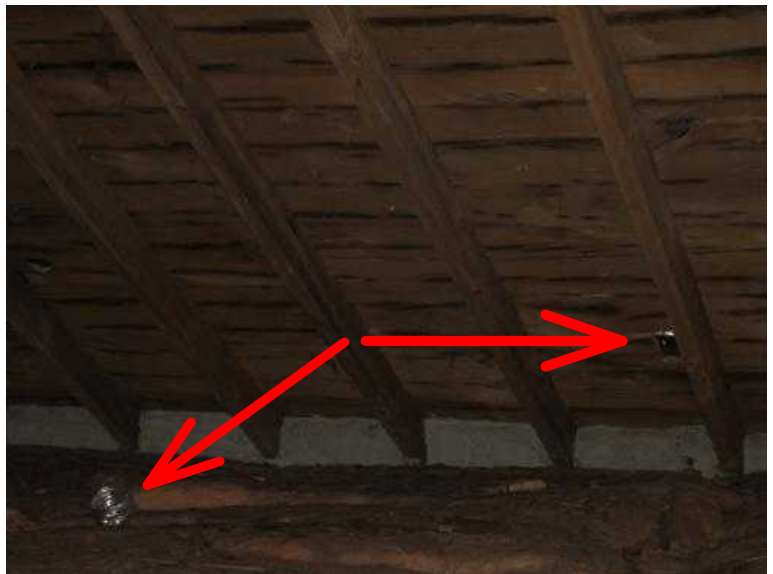
1. Restrictions: 60% visible, Visible from hatch only, Insulation
2. Method of Inspection: From the attic access
3. Acceptable Unable to Inspect: 40%
4. Acceptable Roof Framing: Rafter
5. Acceptable Sheathing: Dimensional wood
6. Acceptable Ventilation: Roof and soffit vents
7. Acceptable, Improve Insulation: Fiberglass batts, Bark chips: +- R20-22 approximate, which is on lower side of acceptable - consider upgrade, Add weatherstripping on attic hatch to prevent warm, moist house air from entering attic and condensing in the winter.
8. Not Present Vapor Barrier: None
9. Defective Bathroom Fan Venting: Metal flex: Bathroom improperly vents into attic and may cause moisture damage to the insulation and any wood in the attic, Extend and insulate the ductwork with specialized insulation/vapour barrier in one, connecting it to the existing collared roof vent

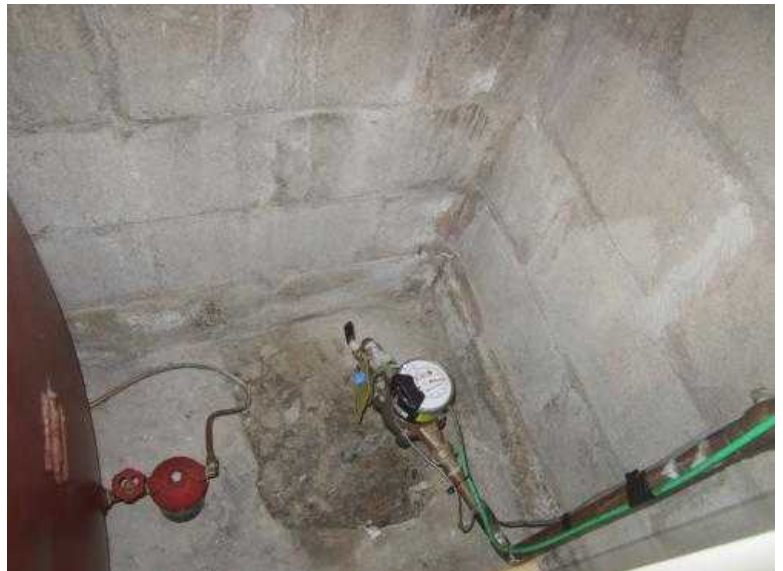
1. Restrictions: Throughout all buildings, wall and ceiling finishes restrict complete evaluation - hidden defects usually go undetected during inspections
2. Acceptable Service Line: Copper
3. Acceptable Main Water Shutoff: Basement (by oil tank)

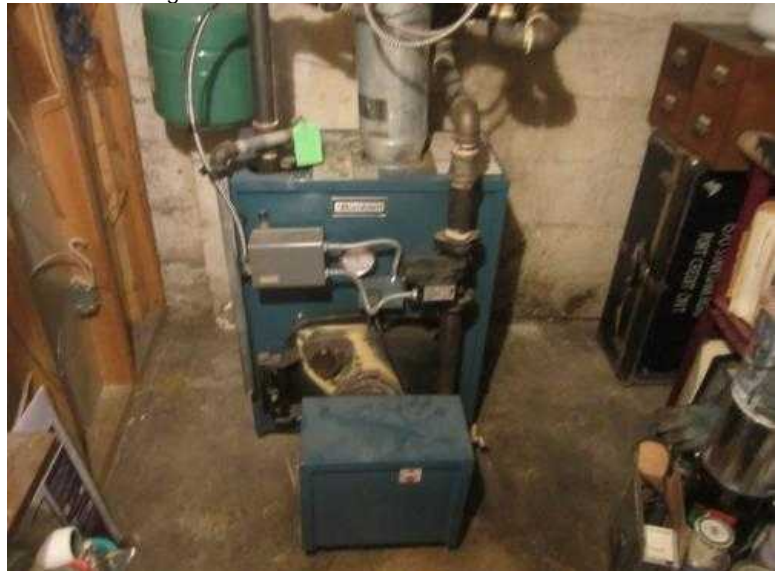
2. Acceptable Heating System Operation: Appears functional: Consult a heating technician to develop an annual maintenance program to maximize the life of the unit. Note that it is advisable to have the boiler cleaned professionally (the heat exchanger included) to ensure peak operating efficiency. Note that supplemental electric baseboard heating exists in the basement
3. Type: Boiler system Capacity: 61 MBH

6. Investigate Oil Burner Box: Typically restricted: An oil burner box is the area where the oil is fired to produce heat. It is lined with a refractory heat -resistant material, and over time, cracking will occur. Part of the annual inspection, which we recommend, would be a professional evaluation of this area. There is some cracking in the refractory material at this time, which means repairs to this area will likely be required at some point in the next year or so.
